Repairing a damaged house by watering foundations: the MACH project

ABSTRACT

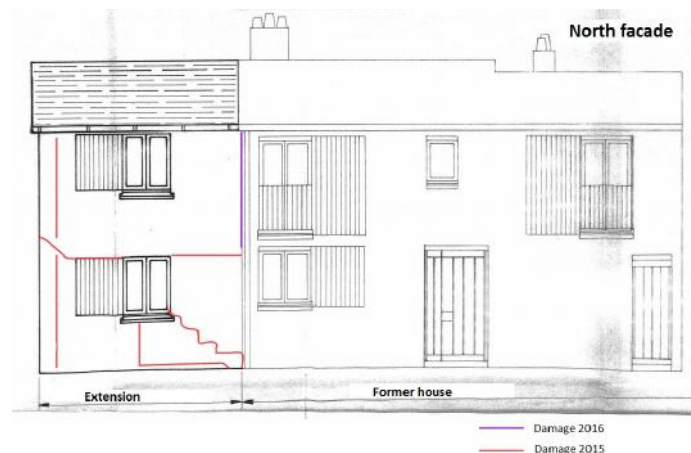
Figure 3: Noticed damage survey in 2015 and 2016

After Summer 2015, the damages were noted only on the extension part of the house. Major cracks were drawn on figure 3. It was found out that the extension is tilting to the East.

The conclusion of the geotechnical survey is that early 2015 hydric deficit induced a severe drying of the clays located under the footing of the house. The hedge of cotoneaster was an aggravating factor for the shrinkage phenomenon. This heavy drying caused settlement of the footing and lead to cracking the east gable of the house.

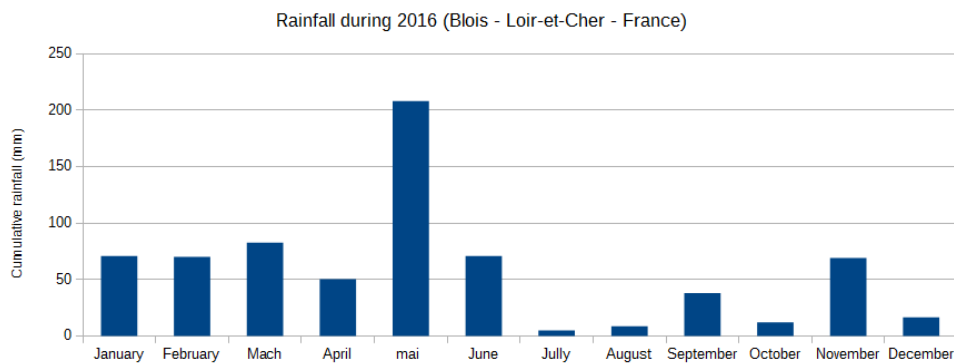
Figure 4: Annual rainfall in Blois (2016)

- 2014 is “a normal year” with 694 mm cumulative rainfall (uniformly spread out across the year) and average temperature equal to 12.5°C. Swelling and shrinkage phenomenon is not a problem in 2014;
- 2015 is dryer than 2014 with only 594 mm annual rainfall and a short drought period during Spring, June and July. Important rainfalls during August and September avoided a major drought;
- Annual cumulative rainfall in 2016 is over 720 mm but with an exceptional rainy Spring (over 210 mm rainfall during May!). Despite this rainy Spring, 2016 is considered as a dry year, especially after June (figure 4).

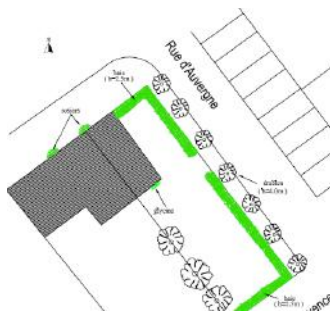
Figure 5: vegetation survey

Every shrubs or trees are transcribed on a plan (figure 5). A cotoneaster hedge is located just in front of the damaged gable of the MACH. A wisteria is also noted on the south facade.

Early November 2016, the cotoneaster hedge and the wisteria were removed (see figures 7 and 8). The hedge was substituted by a metallic fence with a green screen.

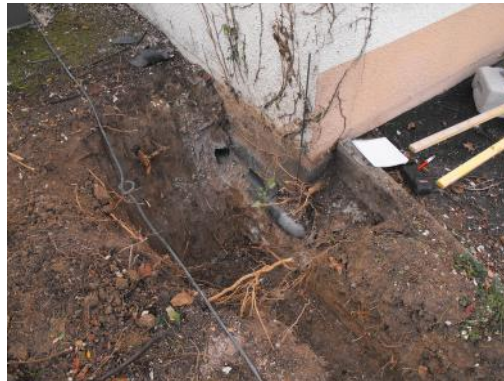
Figure 6: excavator drilling (with numerous roots)

An excavator drilling was realized in front of the most damaged edge of the house. It shows that the foundation system, which is an 85 cm deep footing, is set on the soft and plastic clay. The footing is 35 cm thick. Numerous roots are observed in the excavation (see figure 6).

The foundation soil is a soft and plastic clay (PI \approx 37 to 39), sensitive to swelling and shrinkage phenomenon. Beauce limestone lying under the clay layer is not sensitive.

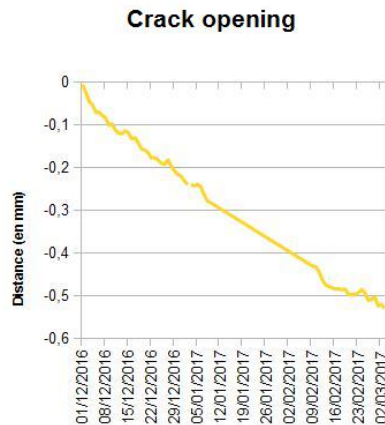
Figure 14: Crack monitoring

During Fall, the MACH's owner declared that interior doors and windows were really hard to close and open. In October 2016, a new vertical crack was observed on the North facade of the MACH, illustrating the east tilting movement of the extension.

noted that doors and windows were easier to use. Furthermore, a clear closing of the monitored crack was recorded in December 2016 (see figure 14).

Thus, Cerema decided to open the valve in order to release water in the injection points. The tensiometric probes recorded the quickly moistening of the clayey soils. The MACH's owner
