Croydon Tram Accident 9 November 2016

The Accident

Main findings of the RAIB investigation

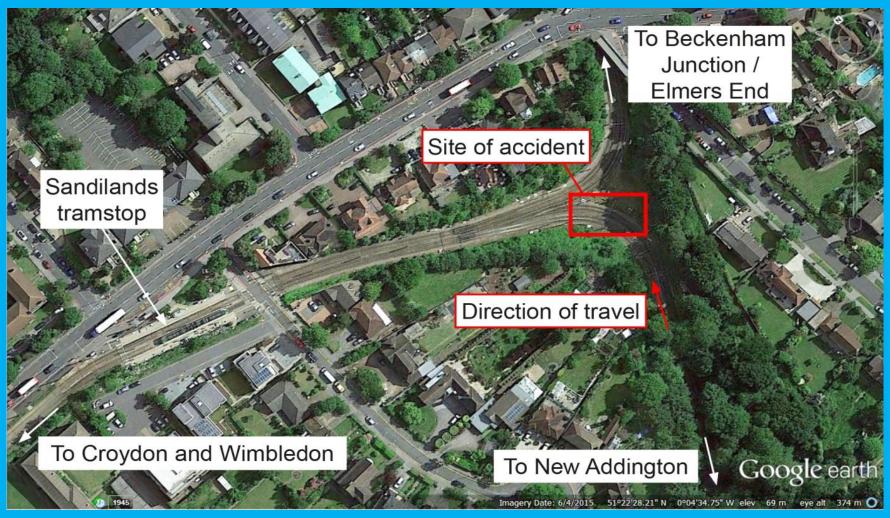
The crash site

- 9 November 2016 at 06:07
- Dark, raining
- Sandilands Curve, 30m radius, limit 20 km/h
- Tram entered curve at 73 km/h
- Tram overturned and slid 20 metres
- 7 passengers killed, 62 injured (19 seriously)
 - Only 1 passenger escaped injury
- Passengers killed by being ejected through broken windows and doors

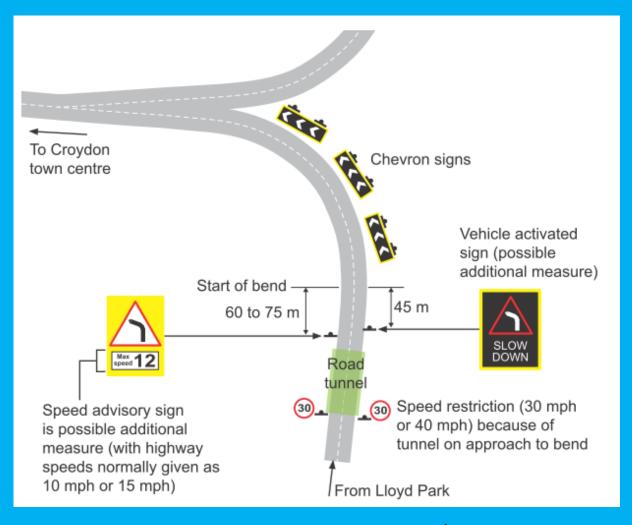
UK Road signs for a similar bend

"Bend ahead" signs, advance warnings, chevrons

- "Count-down" speed limits and chevron signs installed at Sandilands curve
- All other bends on Croydon tramway reviewed and extra signs installed
- Overall speed limit reduced from 80 km/h to 70 km/h
- All other UK tramways reviewed their signs and installed extra signs where necessary
