## **Tram derailment in Lyon after collision with car – August 2015**

**BEA-TT's technical investigation and  
recommendations**

**Laetitia FONTAINE, Accident investigator, BEA-TT**

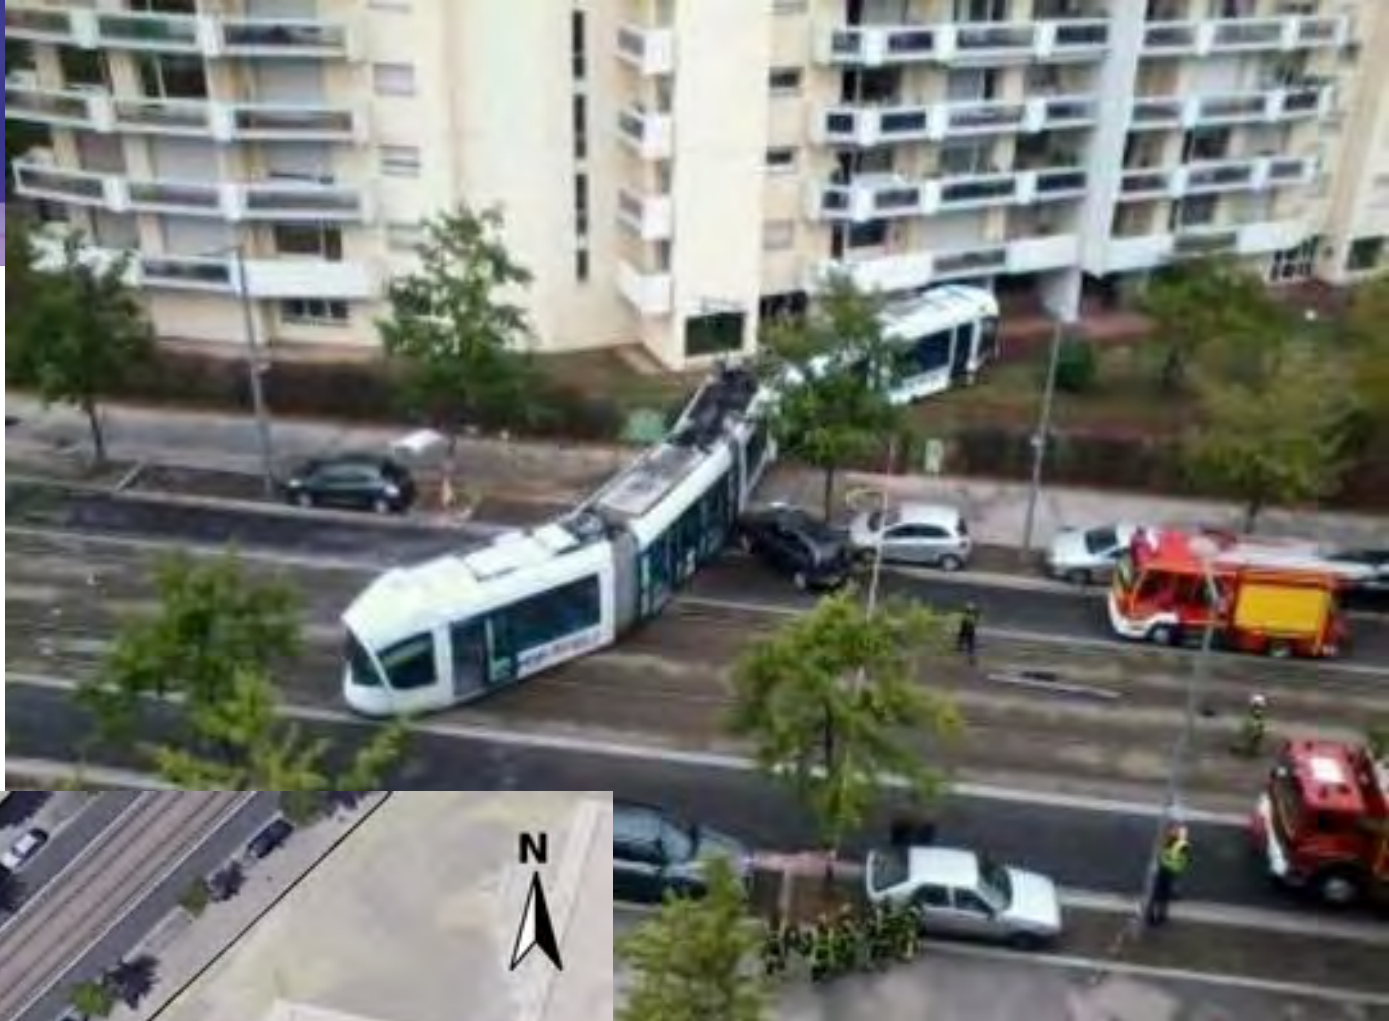
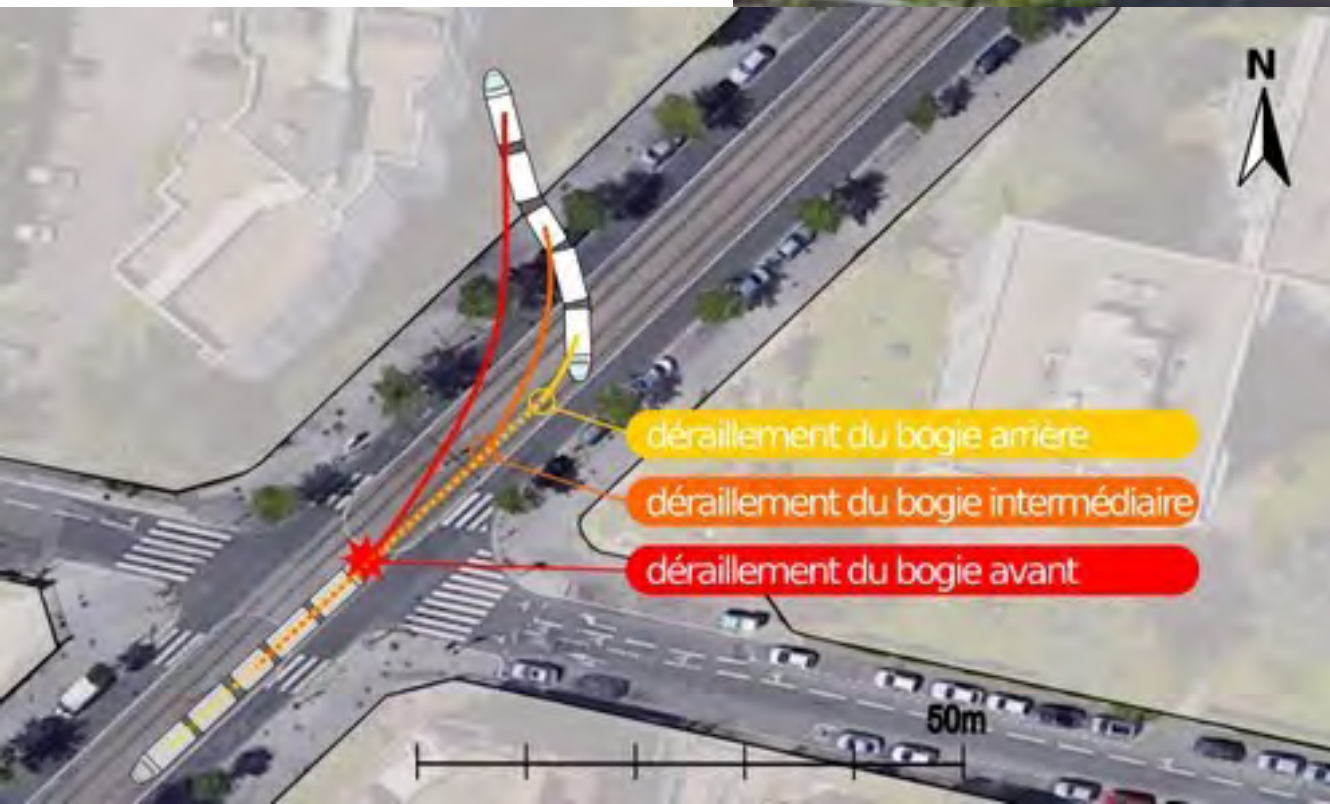
# ① Visualisation

déraillement du bogie arrière

déraillement du bogie intermédiaire

déraillement du bogie avant

50m

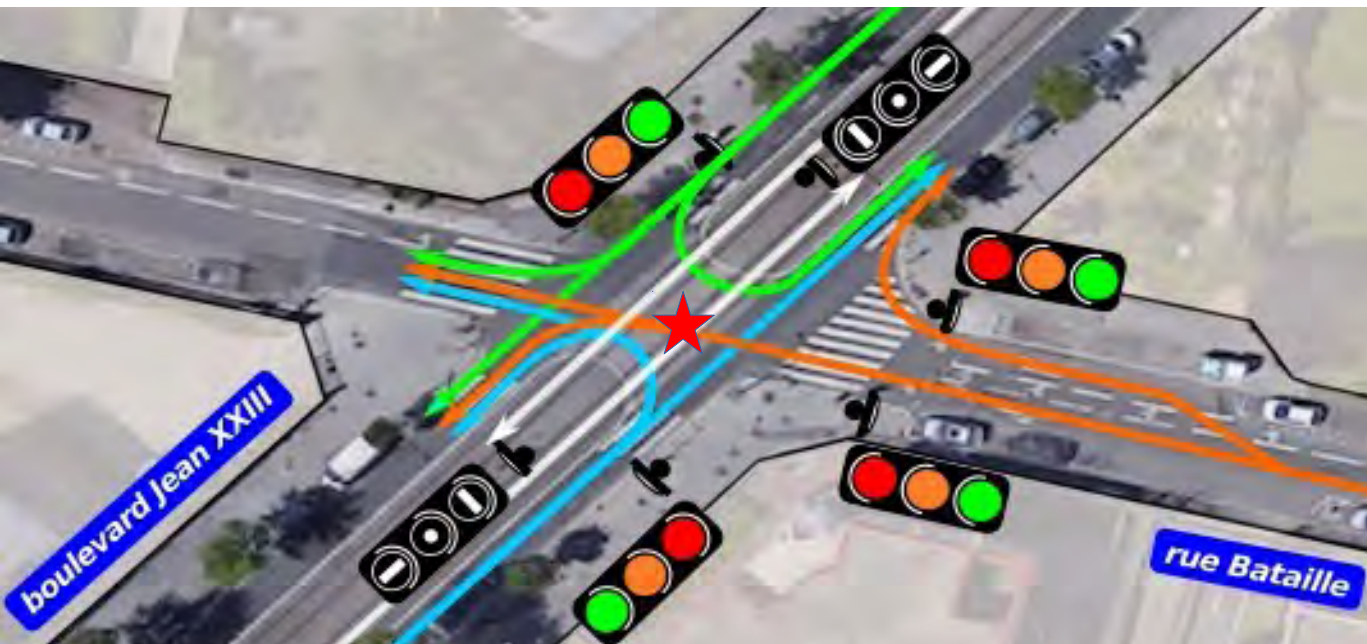
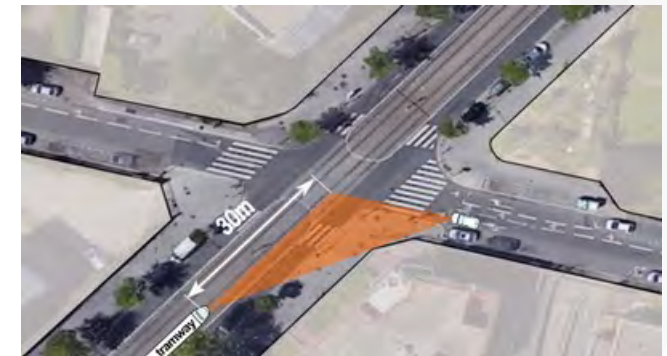
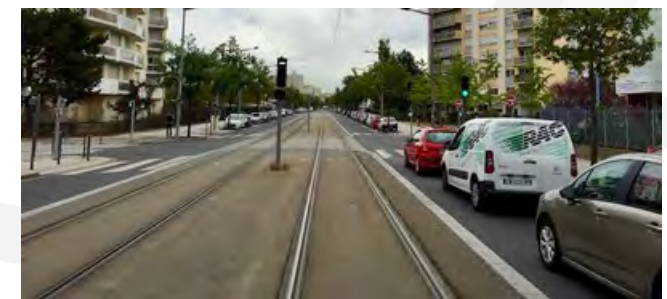
# ① Where it happened ?

- Junction of 2 roads at 120°, tram line is centred
- Rue Bataille is one way, two lines of cars, one phase
- All traffic lights are red when the tram crosses

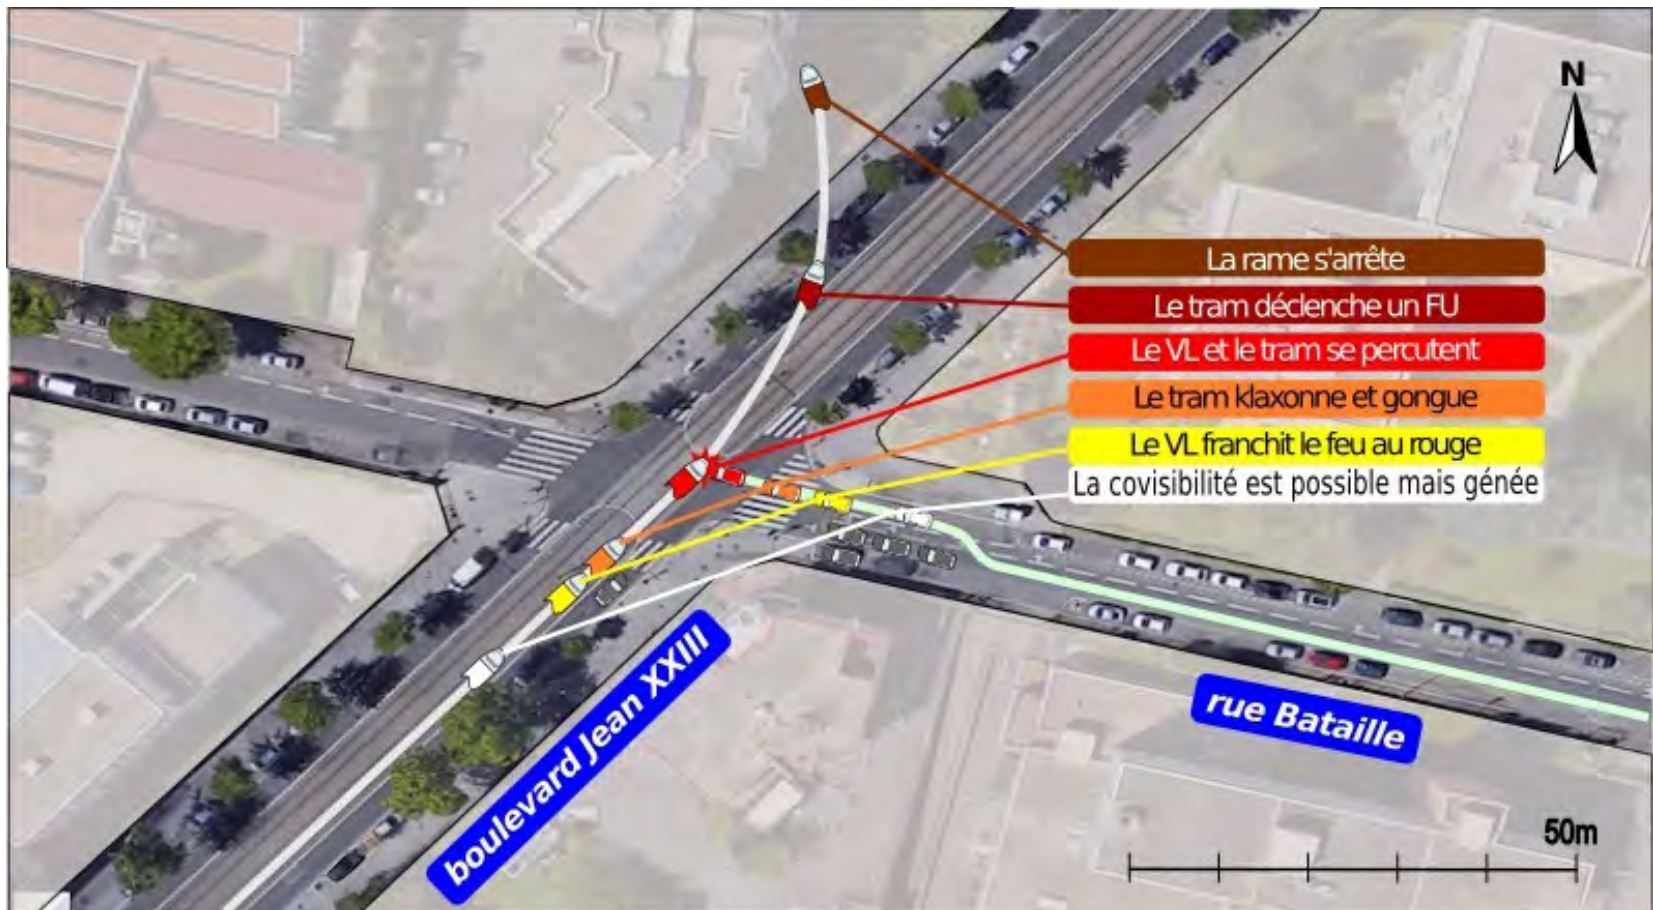
# ① How it happened ?

- Car has not respected the red traffic light
- Car has not applied the breaks, tram applied EB after collision
- Collision = car at 29 km/h and tram at 47 km/h

- Direct cause = car driver has not respected his traffic signalisation, on red light for 30 seconds
- Inattention and lack of mutual visibility
- 2 other factors have made this derailment so consequent :
  - High sensibility to derailment in this type of rolling stock when colliding with cars
  - High speed of the tramway and the absence of breaking by the tram driver before the collision

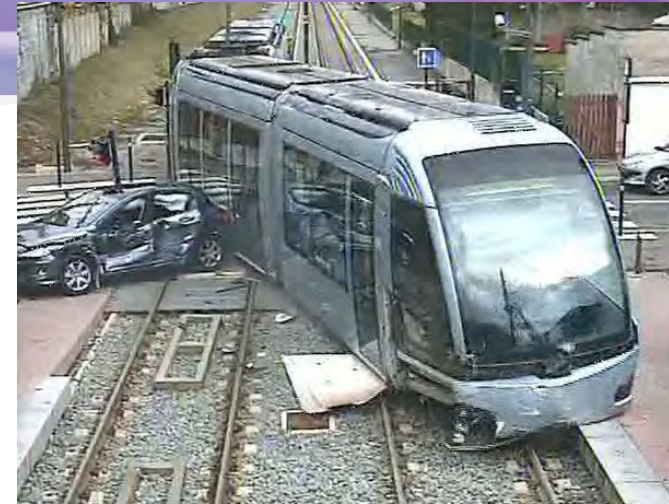
## ② Feedback from Valenciennes's accident

- BEA-TT had made recommendations on tram derailment  $\Rightarrow$  STRMTG guide on conception of trams' front head (oct 2016)
- This guide proposes a method which determines through modelling, the theoretical speed of a car that makes a tram (30 km/h) derail, in a 90° collision at the extremity of the front cabin
- $\Rightarrow$  to check if the car's speed making the tram derail, is above or equal to the existing rolling stock (defined as "the reference" by the manufacturer)
- Alstom has applied this methodology to his range Citadis X05 (on-going conception and production). Alstom has compared it to the existing X02 = its reference  $\Rightarrow$  have a similar "derailability"
- **So, sensibility to derailment is better evaluated now. But there is no significant improvement compared to X02...**

For the tram types not yet developed, in the application of the guide « *Conception des bouts avants des tramways* », do not validate a reference of rolling stock with no favourable feedback as the Citadis X02. If the manufacturer can't reasonably propose an other reference, demand a significant improvement of the derailment rate compared to the reference or compensatory measures notably reducing the importance of a derailment

Propose in the next ranges post Citadis X05, solutions for a significant improvement of the derailability compared to the Citadis X02. If not possible, propose compensatory measures reducing the importance of a derailment, these measures could be presented as a retrofit to the actual types

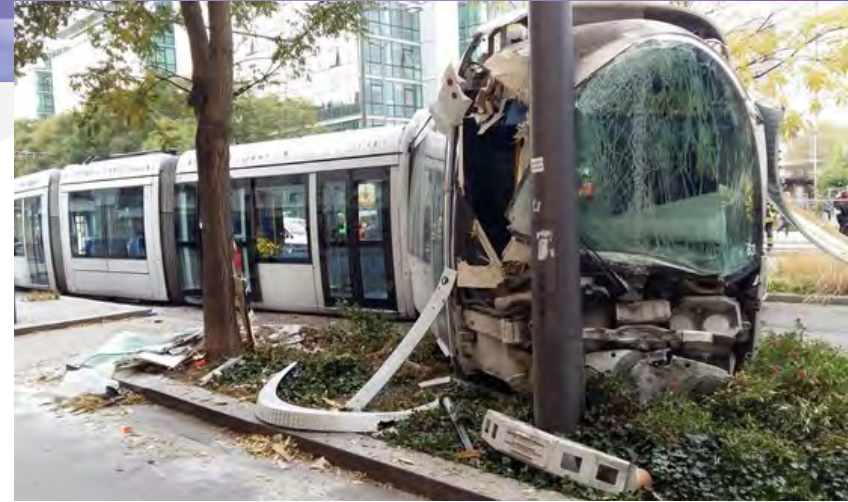
## ② Lyon accident November 2017

- 10<sup>th</sup> of November 2017, 8 h 23
- line T4, junction Bonnel & Villette
- Car has not respected the red traffic light
- Tram has derailed, hit a tree and then a pole supporting the catenary
- 15 slightly injured persons
- Tram was at 40 km/h, applied the normal breaks and then stopped, EB not applied, only the horn (as in 2015)
- Tram hit the pole at 20 km/h.  
If there was the EB when the horn was applied, it could have avoided the collision with the tree & pole

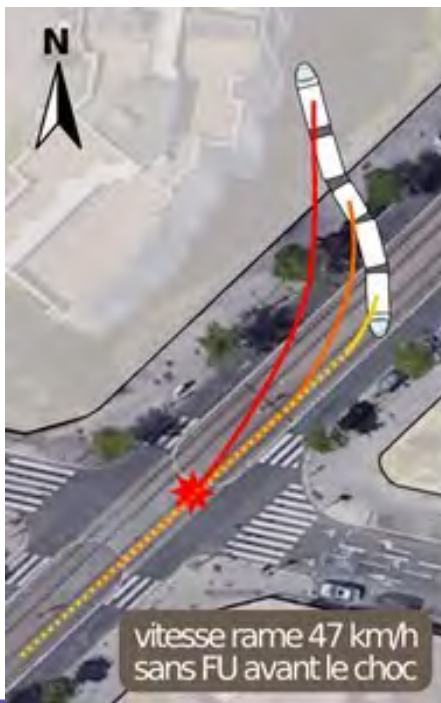
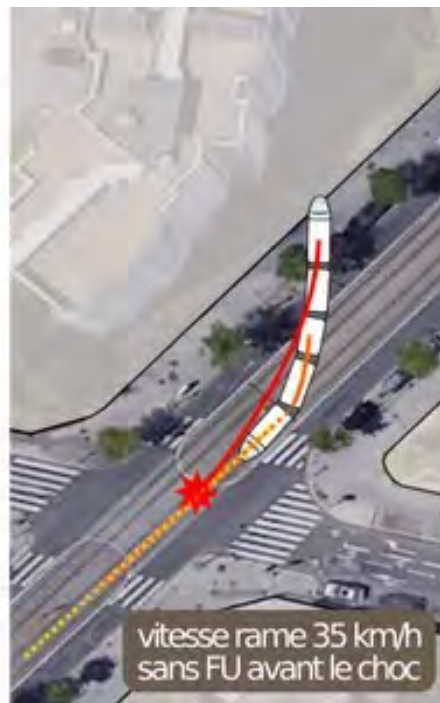
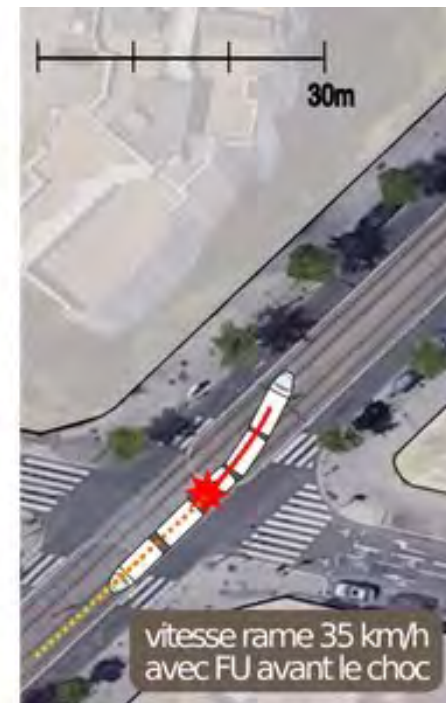
### ③ Which consequences with lower tram speed ?

- Max Lyon = 50 km/h everywhere, no specification for junctions
- Various possibilities have been considered in the investigation :
  - Tram speed = 35 km/h with Emergency Breaking after the collision
  - Tram speed = 35 km/h with EB before the collision

Impose to the trams an adapted speed limitation when crossing the intersections, adapted to the danger and visibility, and in general between 30 and 40 km/h.

Precise, in driving rules and in the drivers' trainings, the modalities to approach and cross the junctions in order to prevent collisions.
