**« Collision of two tramways in Paris »  
11<sup>th</sup> February 2019  
On-going investigation**

**Laetitia FONTAINE**

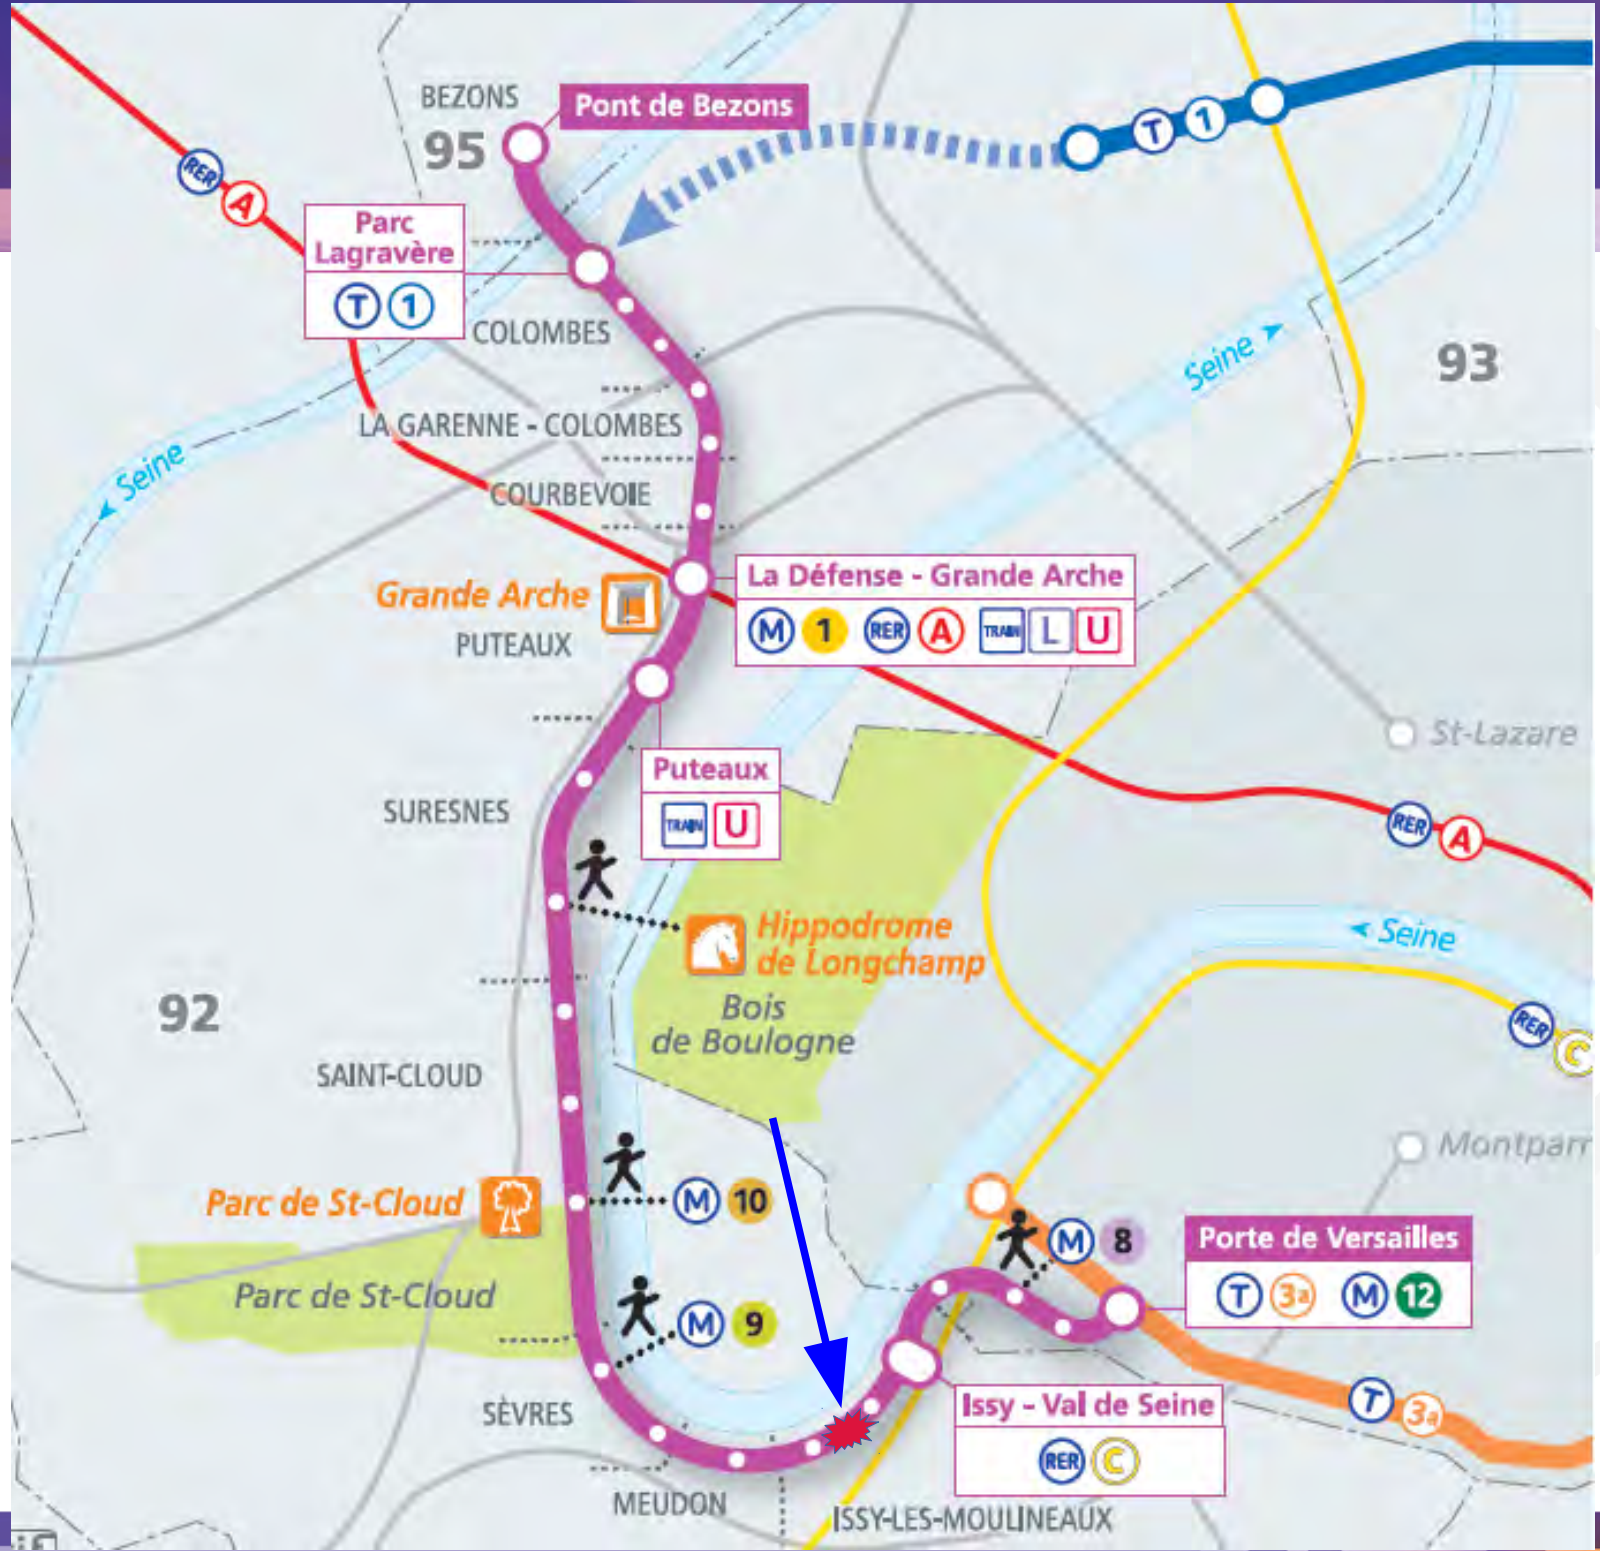
- On Monday the 11th of February 2019 around 21:00
- On line T2 at Issy-les-Moulineaux, next to Paris
- Between stations Jacques-Henri Lartigue and Les-Moulineaux, in direction of Pont de Bezons
- Collision between two double-rolling stocks, one stopped in front of a signal, waited there and the other (401/16) hit it to the rear

- Consequence = derailment of both involved tramways
- Maintenance worker alerts the PCL
- Operation and energy are stopped

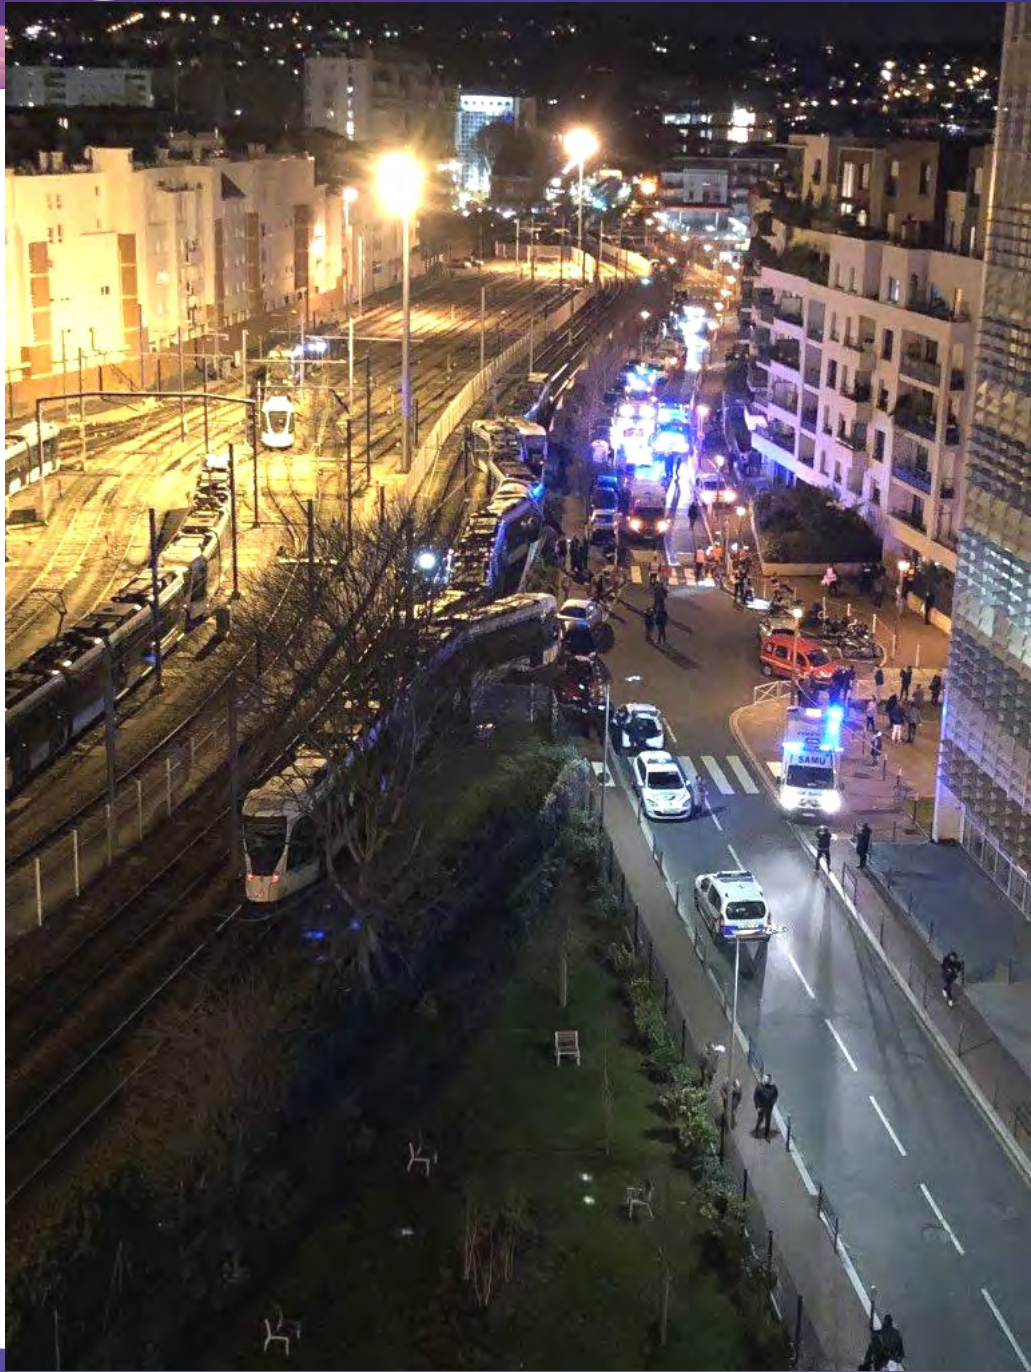
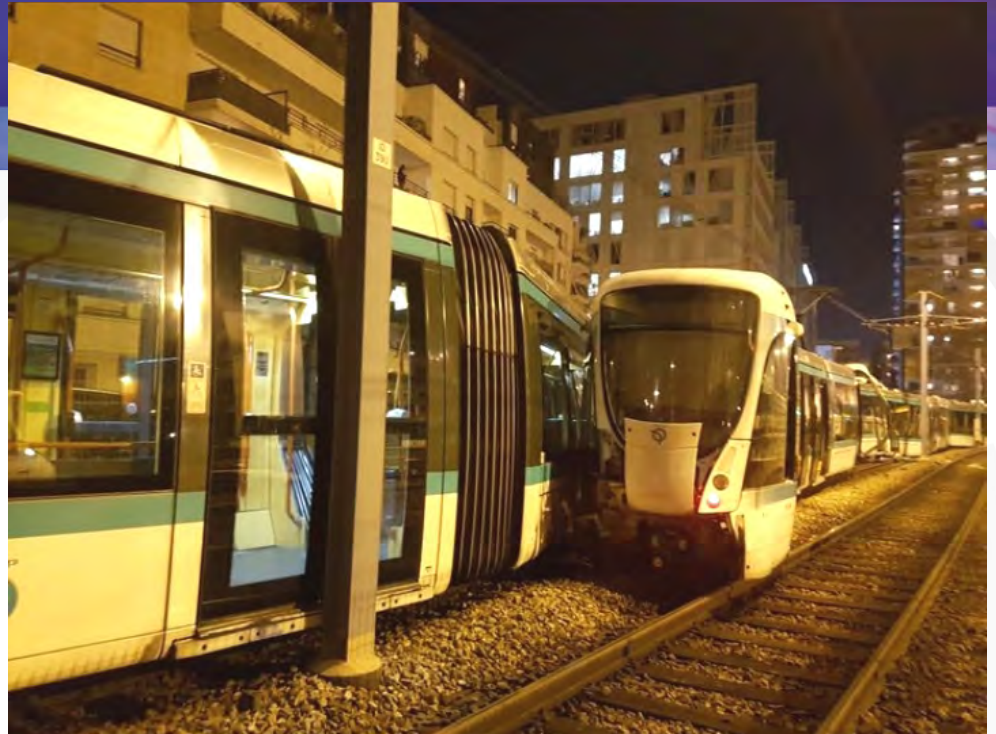
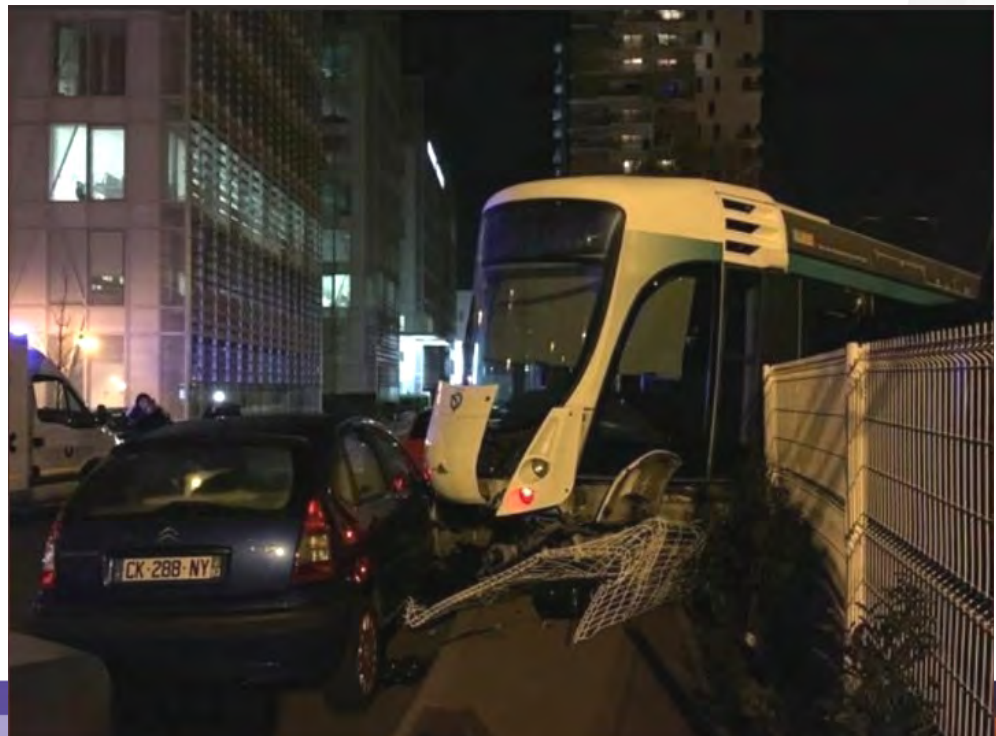
- No road or pedestrian intersection
- Slight curve
- Speed limit is 60 km/h (max of the T2 line is 70)
- Ballast + protected by fences and bushes

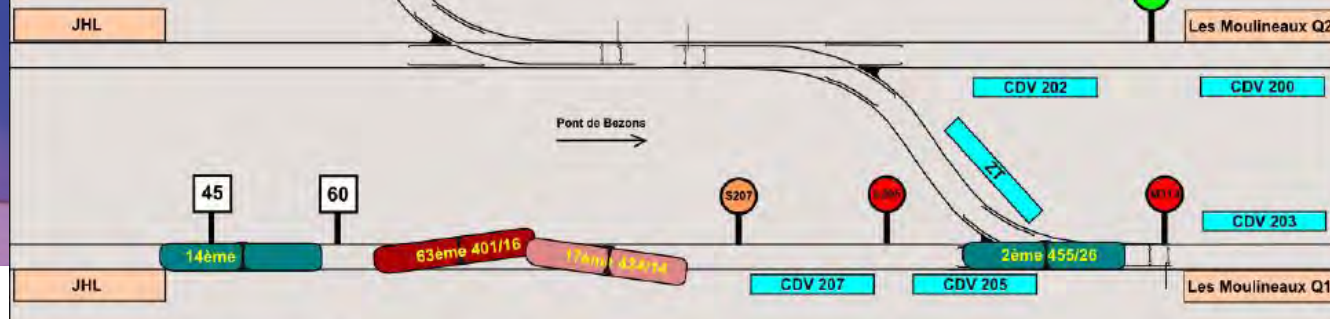
- A tramway (434/14) was stopped on the line, in front of a internal traffic light + with its flashing orange lights in function
- Stopped there to make possible for the tram 455/26 to drive back to the maintenance site
- An other tramway (401/16) saw 434/16 late, made an Emergency Break at 57 km/h
- Hit him by the back at 39 km/h
- After the collision, 14 persons were injured including the 2 tram drivers
- Alcohol and drug tests were negative for both drivers
- Tram driver is a good one + he is a trainer
- PCL has sent oral messages through the radio but the involved driver claims he has never received it

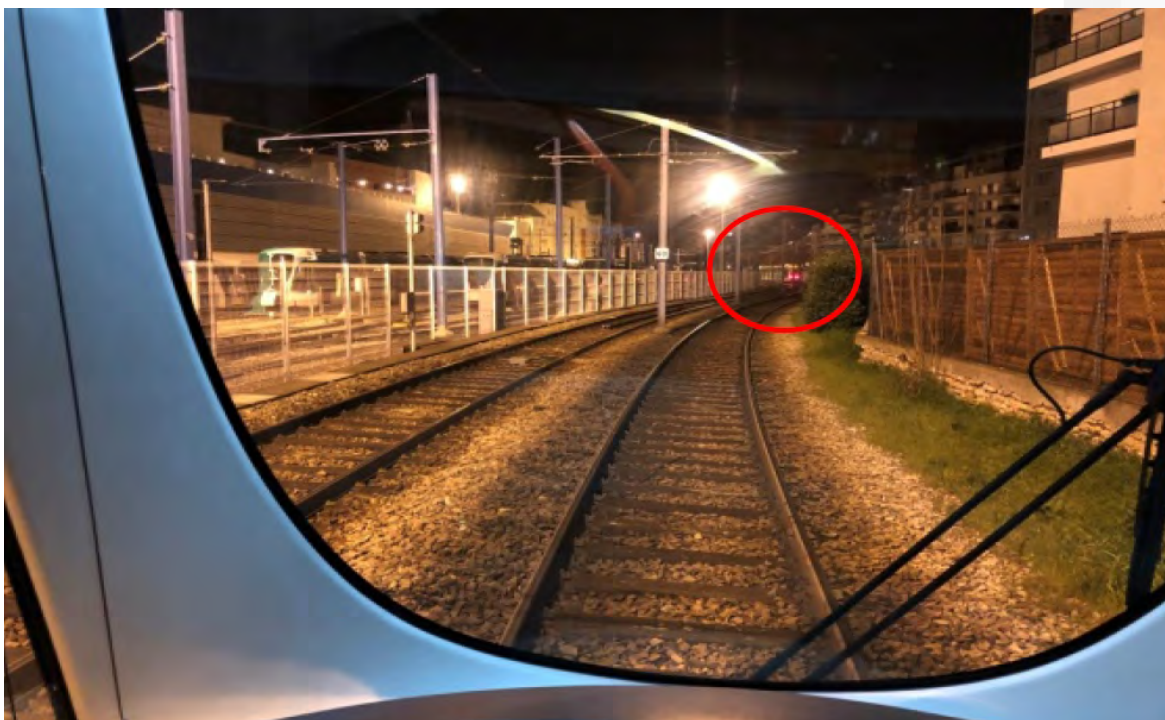
- Hypothesis of a mask to the visibility (barrier and/or bushes), making his seeing the next tram and his decision to brake late has been excluded by the operator  
Where is the complete view on the tram stopped possible?
- How many seconds had he to react ?
