State of Art

French research and knowledge on expansive soils

by David MATHON*

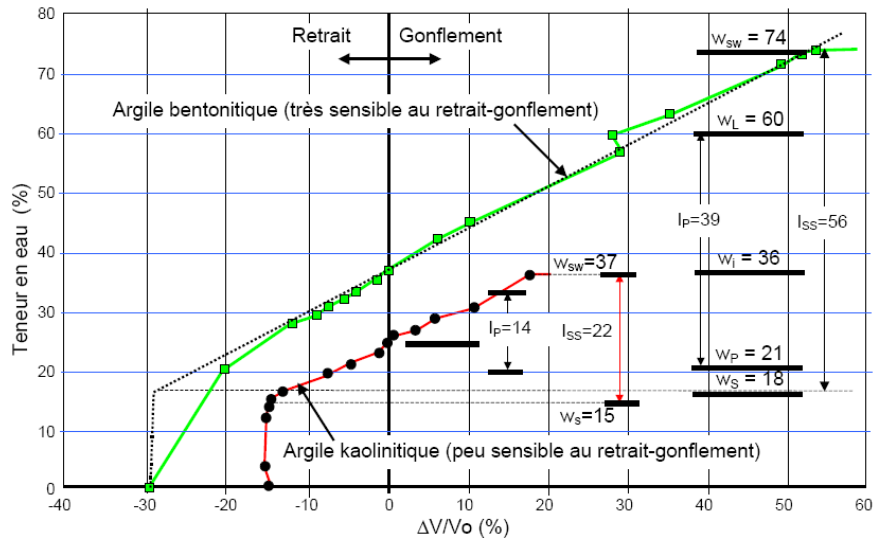
Illustration 1: relation between volumetric variations and moisture (for two French soils) – Magnan and Burlon

On a macroscopic scale, therefore, clayey soils have the characteristic of changing their volume according to their moisture. This characteristic has been known and described in the scientific literature for many years. Magnan and Burlon described this behavior at the opening of the SEC 2015 symposium on the illustration 1.

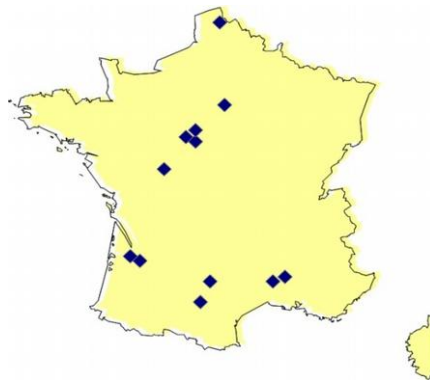
Illustration 2: Location of the ARGIC experimental sites

13 experimental sites were equipped on the whole metropolitan territory illustration 2, I will here detail two test sites located in the south-west of France near Bordeaux.

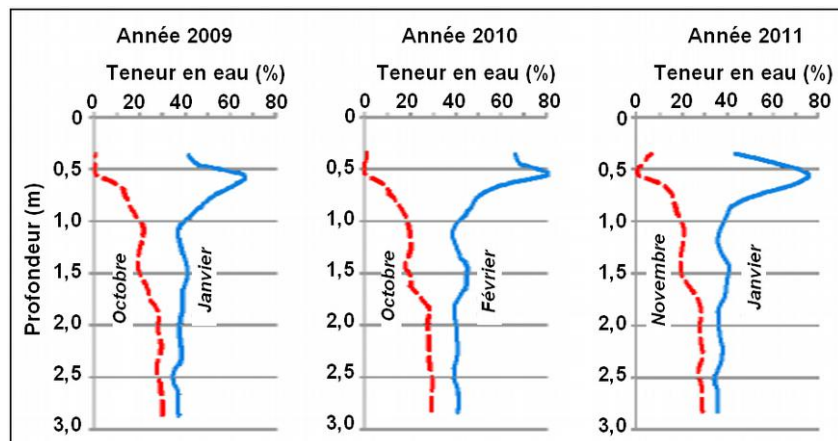
Illustration 3: volumetric water content profiles over 3 years

Measurements of water content are made using TDR (Time Domain Reflectometry) probes which measure the dielectric constant of the soil in relation to its volumetric water content. The highest annual variations are about 19 to 24% in volumetric water content (12 to 16% moisture). The illustration 3 shows that the moisture variations are observed up to at least 3 meters deep, which means that the shrinkage of the soil can be mobilized up to this depth.

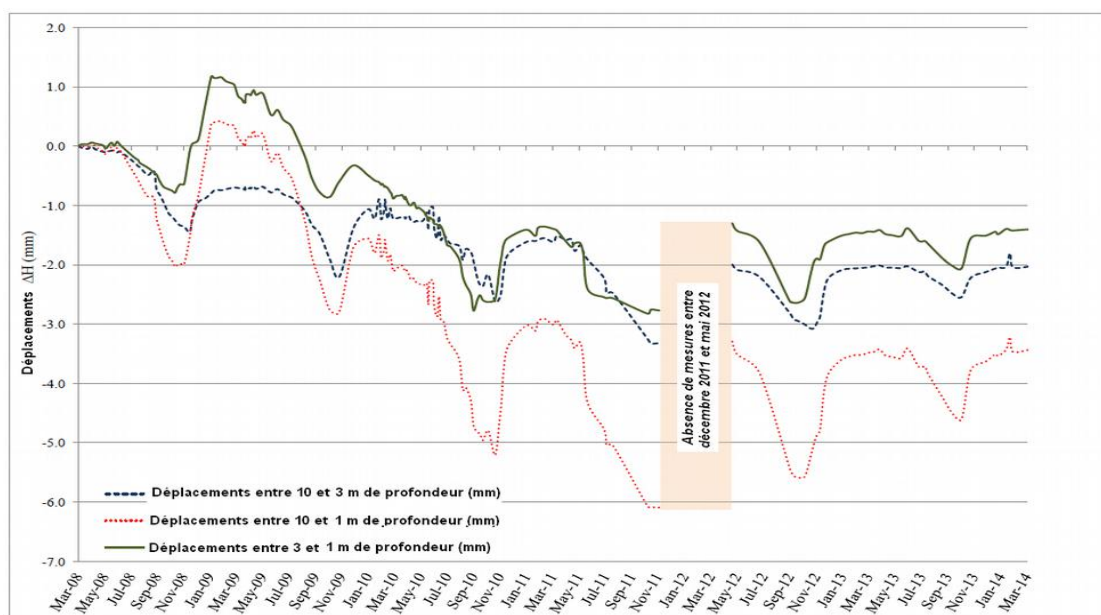
Illustration 4: deformation between 2008 and 2014 (Telemac extensometer) – Fabre and al.

Considering deformation, measurements made with different type of extensometer show similar results (illustrations 4 and 5).

- 50% of the deformations are between 1 and 3 meters deep;
- there is a multi-year cumulative phenomenon that is particularly observed between 2008 and 2011 (shrinkage phase).
- The amplitudes measured are of the order of 5 to 6 mm maximum.

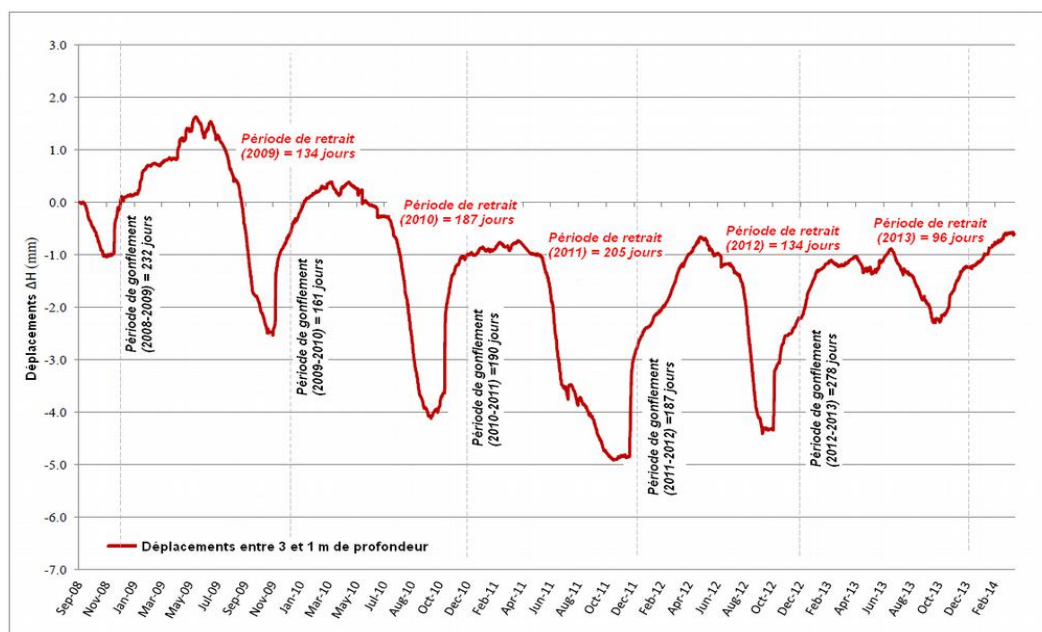
Illustration 5: deformation between 1 and 3 meter deep (Glötz extensometer) – Fabre and al.

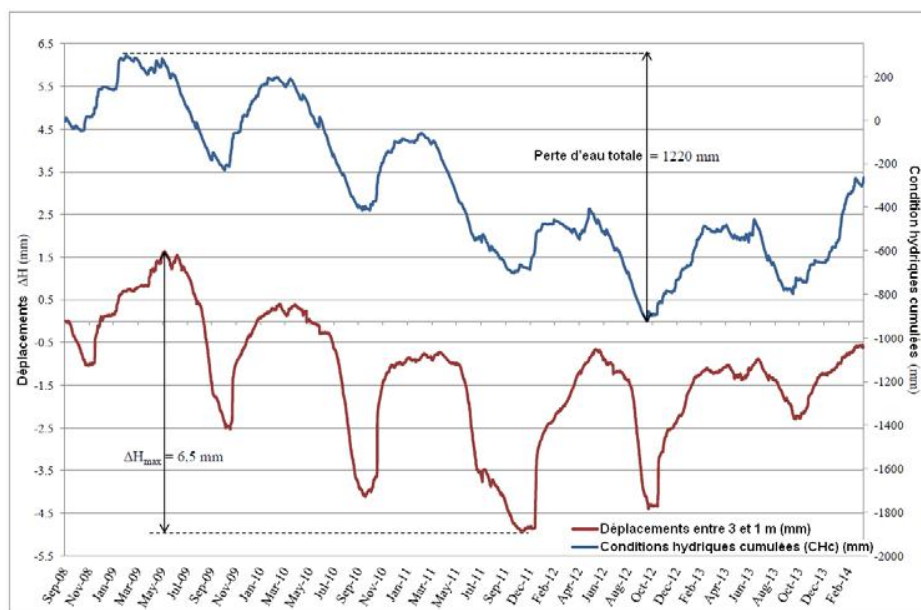
Illustration 6: *Chc Curve and displacements measured between 1 and 3 m deep – Fabre and al.*

On illustration 6, there is a remarkable correlation between the representation of CHc and the recorded deformations of the soil between 1 and 3 meters (Glotz extensometer).

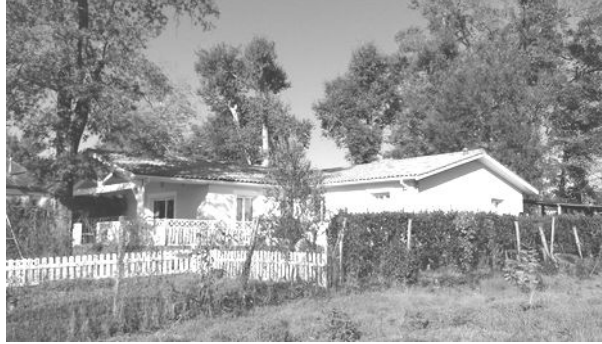
Illustration 7: Equipped house

The considered house (illustration 7) was built in 2004 and 2005, it is located in Roaillan in the French department of Gironde at a locality called “le laurier” (Neveu, 2012). It is a ground-floor, L-shaped individual building; its area is about 160 m². Its foundation is a footing anchored between 50 and 80 cm depth under the natural soil. The basement walls are made of concrete blocks and the walls of bricks. The floor is a concrete slab on ground based on the footings.

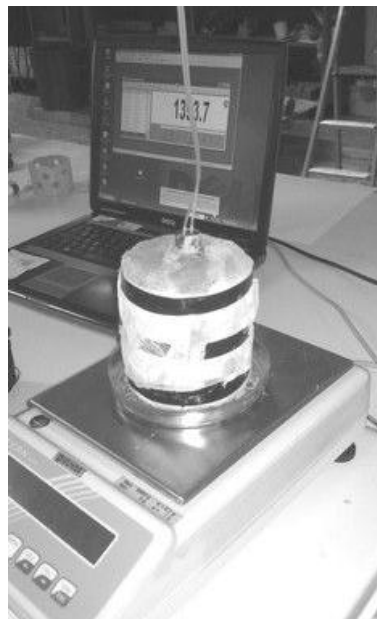
Illustration 9: Calibrating a soil sample in laboratory

The Cerema conducted calibrating in laboratory in order to find a connection between weight moisture content of soil and tension measured by the probes. This experimentation was conducted on soil samples “multicolor clay H2” and “beige, stiff clay H4” at 2.3 m and 4.3 depths (illustration 9).

The calibration consist to monitor the air drying of a previously saturated soil sample. The monitoring consists in measuring tension and its weight every 15 minutes. The graph of weight moisture content as a function of soil tension shows a shape conform to retention curves found in the bibliography (illustration 10). Note the significance of lithology and soil plasticity regarding measured tension values. Exploiting those curves allowed to establish a theoretical relation between a measured tension value and an estimated moisture.

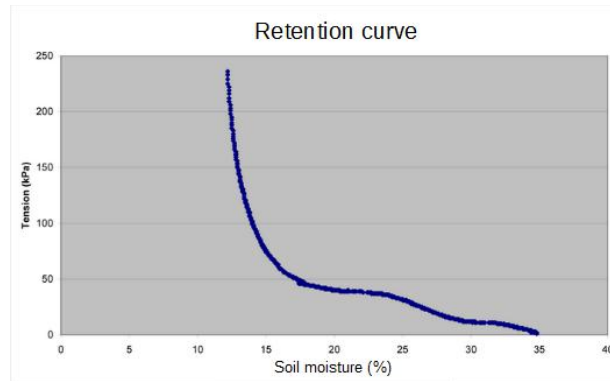
Illustration 10: Soil retention curve

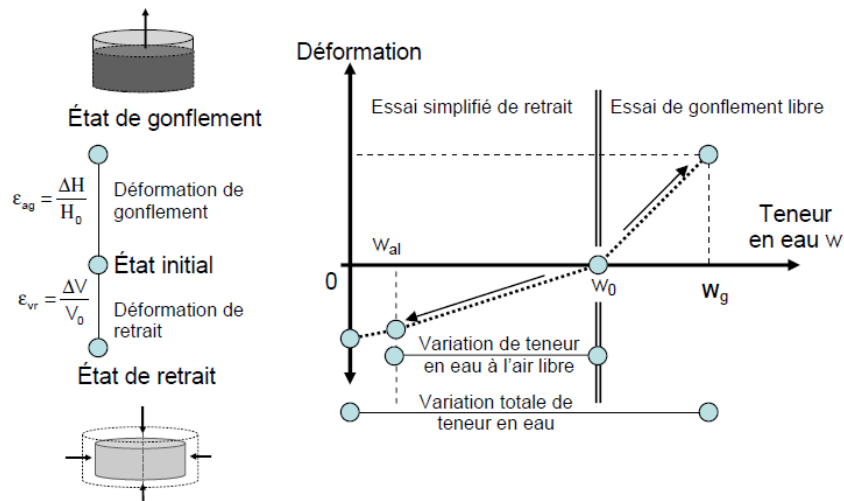
Illustration 13: Shrink and swell test on two separate samples

variations requires to perform simultaneously a shrinkage test and a swelling test (illustration 13).

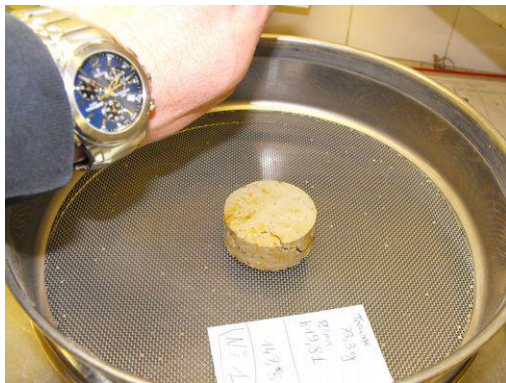
Illustration 14: shrinkage test

The shrinkage test consists in allowing a sample to air-dry for 4 days by regularly measuring its dimensions and weight (illustration 14). The sample is then dried to define the moisture and void index of the soil.

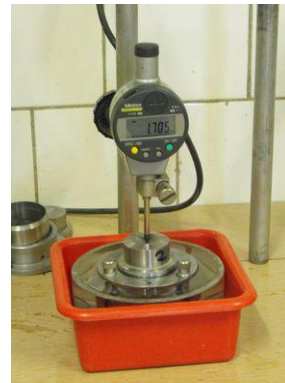
Illustration 15: free swelling test

The swelling test is a free swelling test in an oedometric frame (illustration 15). The test is stopped when the swelling is stabilized. The height of the sample is then measured as well as its weight (to find its moisture).

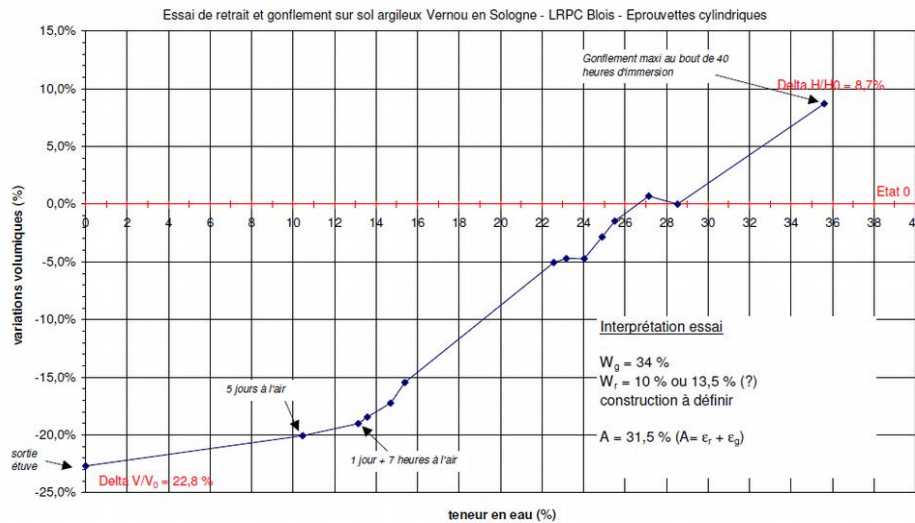
Illustration 16: Volume variations of a sample as a function of the moisture

The collected information defines a total index of shrinkage-swelling which characterizes the soil. This index is called Ass (for Amplitude Swelling and Shrinkage).

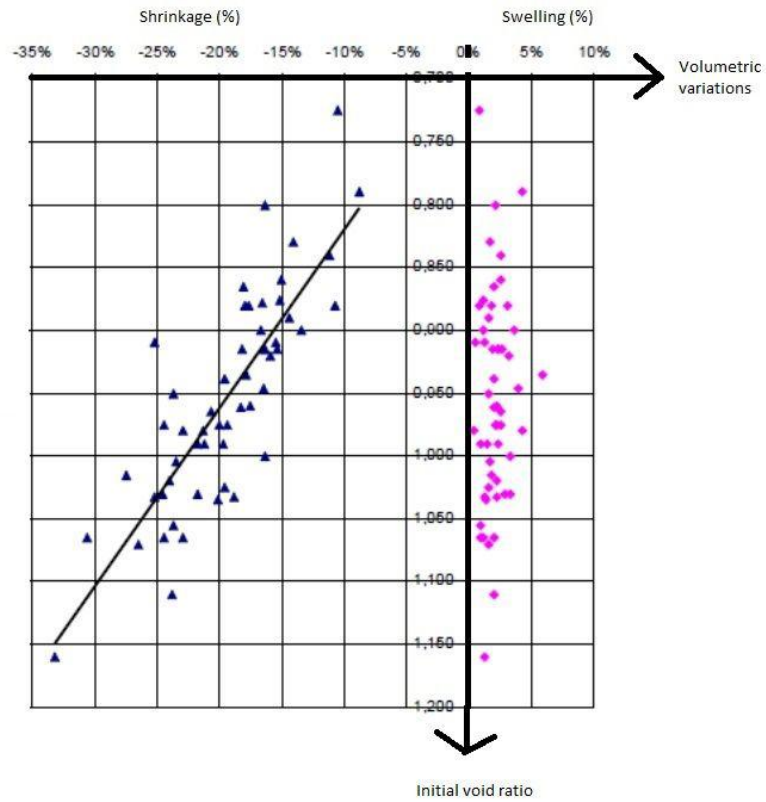
Illustration 17: Correlations between void ratio and shrinkage potential (Cerema Lille)

Soil compactness has an effect on the shrinkage and swelling potential of a soil. Dense soils tend to swell whereas loose soils tend to shrink. Furthermore, shrinkage range seems to be linked with initial void ratio of the sample (illustration 18).

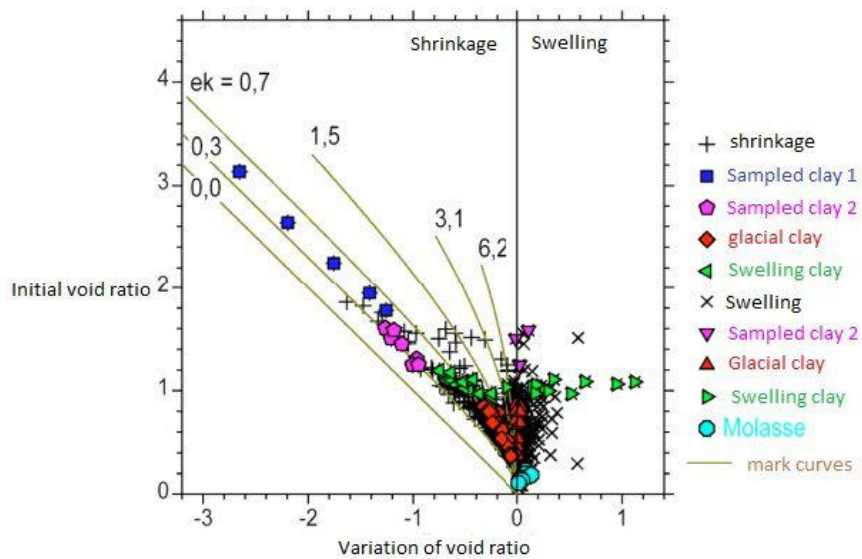
Illustration 18: Effects of initial void ratio on shrinkage and swelling of a sample (Cerema Aix-en-Provence)

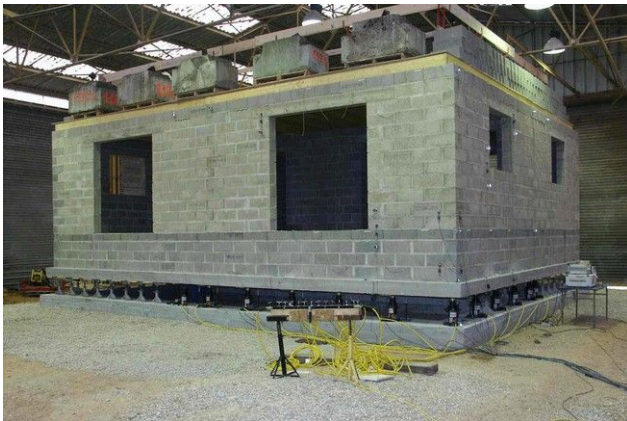
Illustration 23: view of the MISS

The principle of MISS is to build a real house (illustration 23), in full scale in a totally controlled environment and to apply strains corresponding to those of the shrinkage-swelling of a clayey soil.

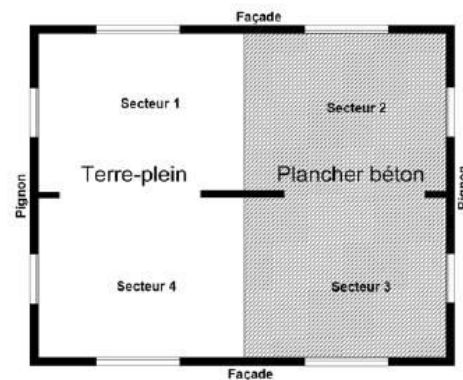
Illustration 24: map of the MISS

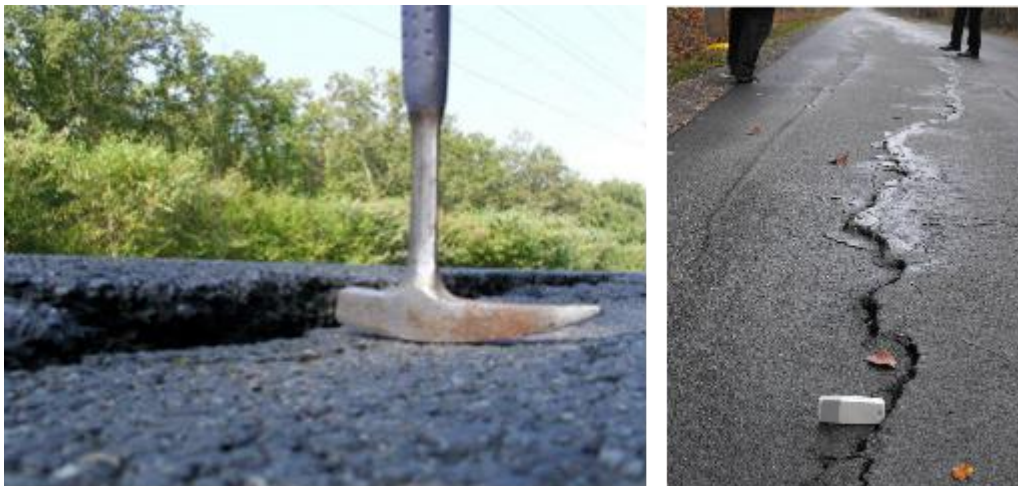
Illustration 25: typical disorders on roads due to drought

Drought induces shrinkage of clayey soils and differentials settlements which cause disorders on roads in France. These disorders have two kinds of appearance: a long longitudinal cracking with a significant lateral settlement (illustration 25). Most of the time, these disorders appear when vegetation is close to the road (hedges, forest edge...).

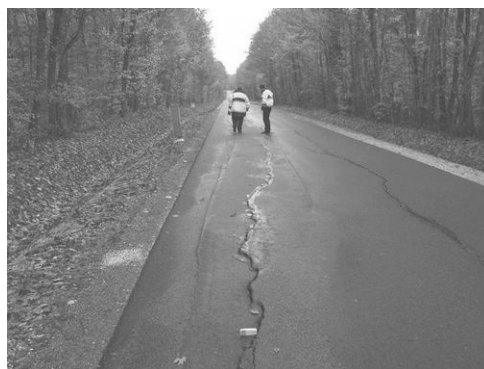
*Illustration 27: longitudinal cracking
(adaptation cracking)*

The site diagnosis was made in November 2010 at the request of the road manager. The road already repaired in 2007 was showing numerous pathologies: alligator cracking, bleeding, important edge settlements (illustration 27) and longitudinal cracking out of the wheel track.

The nature of soils, the fact that damages are recurrent, the season of appearance (end of summer – fall), their location (across a forest) and the presence of other similar sites led the CEREMA to diagnose a shrinkage and swelling of road subgrade soils (except for the alligator cracking and the bleeding which are linked to traffic and the coated material laying.)

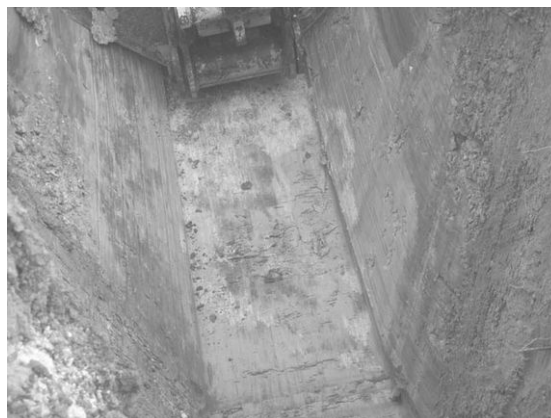
Illustration 28: white clayey layer

In order to know the nature of on-site soils a shovel survey was done on the shoulder of the road (illustration 28) at point n°5 (PR 5). Here, an important longitudinal cracking affects the road.

- A 30 cm layer of dark brown vegetal earth containing a lot of small roots ;
- A silty formation brown beige till 80 cm depth;
- A multi-coloured (grey, rust, brown...) very plastic formation becoming white on the bottom of the drilling, around 2,30 m (illustration 28).

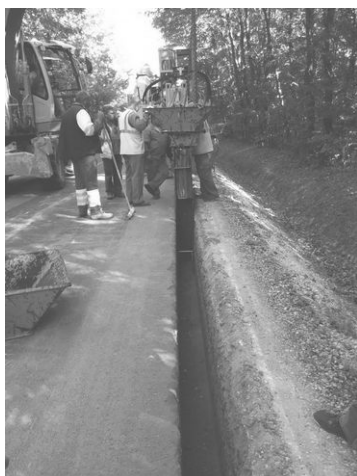
Illustration 29: excavation using a trench excavator

- Making a 30 centimetres wide excavation on the side of the road using a trench excavator (illustration 29). The maximum depth reached by the trench excavator is 1,65 m (this depth limit was announced only during works, even though requirements were to reach 2 meters);
- Filling the trench with fluid concrete, directly poured by concrete mixers (illustration 30);
- Carrying out a milling of the pavement on the whole site and setting up a double surface dressing before re-establishing traffic (illustration 31).

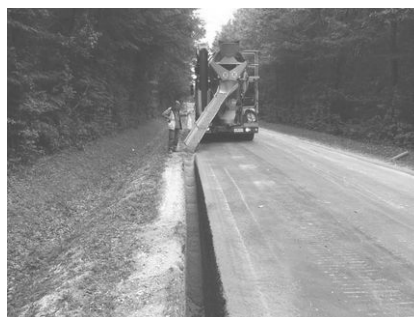
Illustration 30: Pouring concrete by concrete mixers

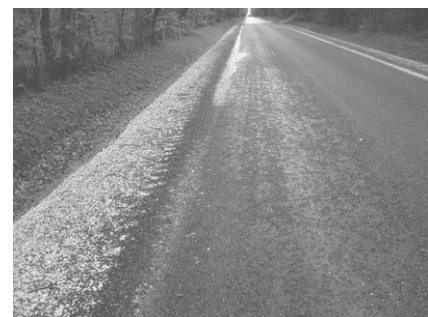
Illustration 31: view of the double surface dressing

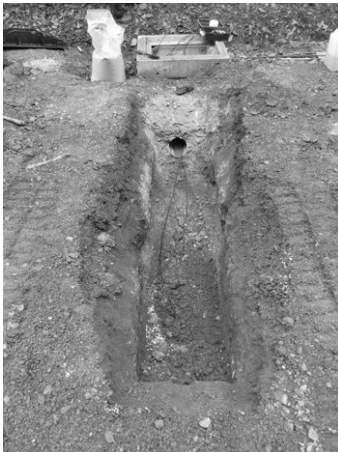
Illustration 32: transversal trench

Note that a pipe was placed through the trenches before pouring the concrete in order to pass connection wires between the probes and the monitor.

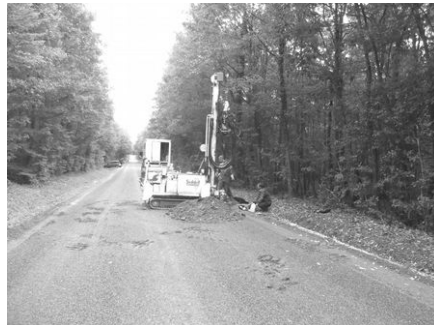
Illustration 33: The probes are installed by the drill

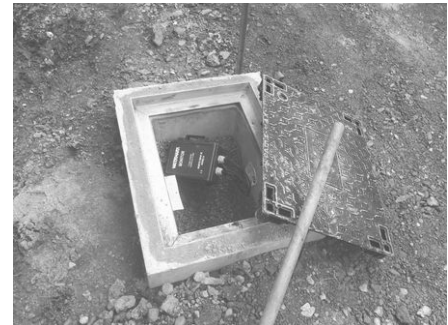
Illustration 34: Recording box in a manhole under the shoulder

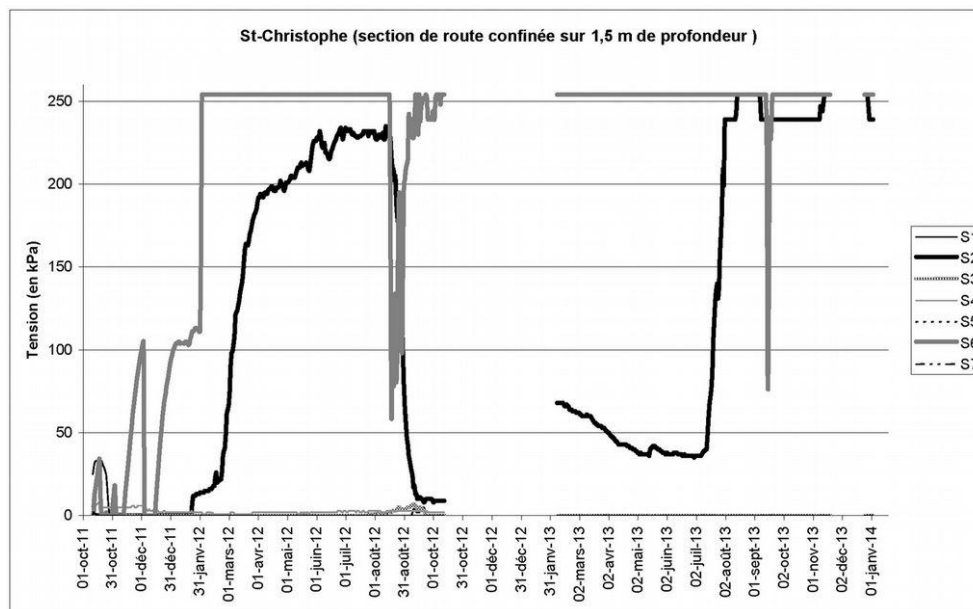
Illustration 36: Suctions evolution on section (-1.50 m)

- A high suction starts in November 2011 in unprotected soils (probe 6). It rises till February, then the recording is stopped (probably because of the strong frost in this area at that time). The recording starts again in late August. The data collected after this date are very irregular and show probable probe deterioration;
- The probe 2, at -2 m near the wall, shows a very strong suction (superior to 200 kPa) between the end of February and the beginning of September 2012. Suction rises again in July 2013;
- Every other probe under the pavement (1, 3, 4, 5, 7) has values inferior to 5 kPa, meaning an overall stable and rather damp humidity state.

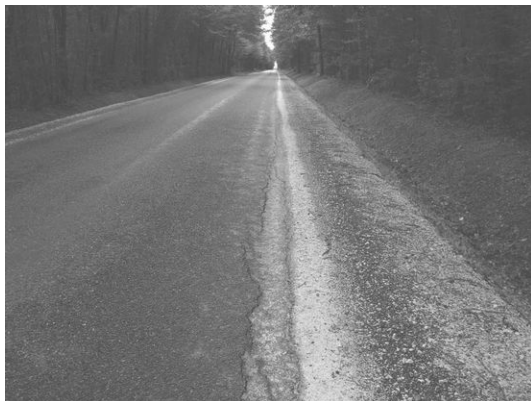
Illustration 38: crack on the side ("beam" effect of the concrete wall)

- Some light longitudinal cracks on the side of the pavement (illustration 38). They are related to the proximity of the concrete wall, which acts like a rigid beam;
- A slightly more significant longitudinal crack located on the road axis (longer, less straight and showing a small slope towards the west side). This crack is at the exact same place than the one seen in November 2010 near the PR 5 (illustration 39) in an area protected by a wall. The wall depth is between 1,5 and 1 m (transition).

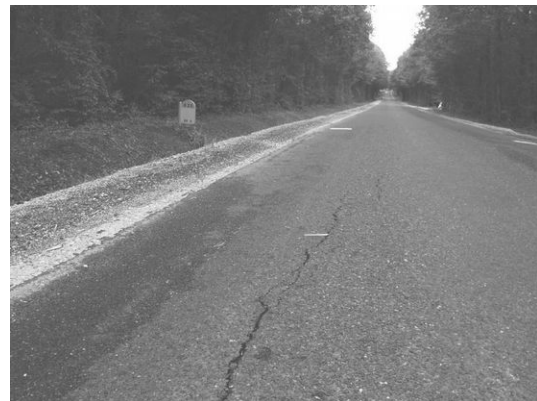
Illustration 39: longitudinal cracking with edge settlement (same place as illustration 27)

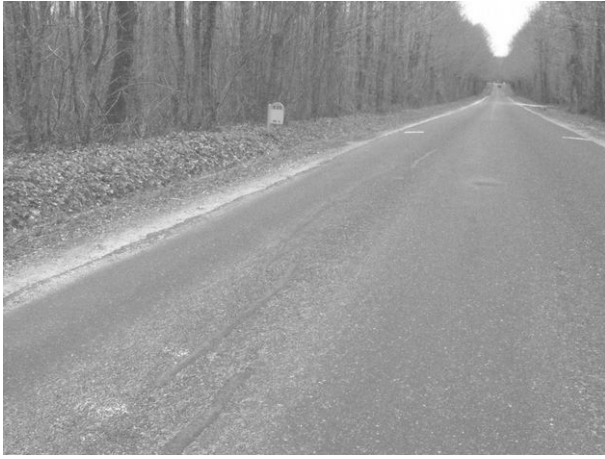
Illustration 40: state of the location at PR5 in January 2015 (3 years after confinement works)

A (rainy) month later, in November 2012, the cracking evolution is small: no increase of its length or of the slope. During year 2013, the manager conducted crack bridging on the longitudinal cracks near PR5. Since this intervention, cracking lengths did not change (illustration 40).

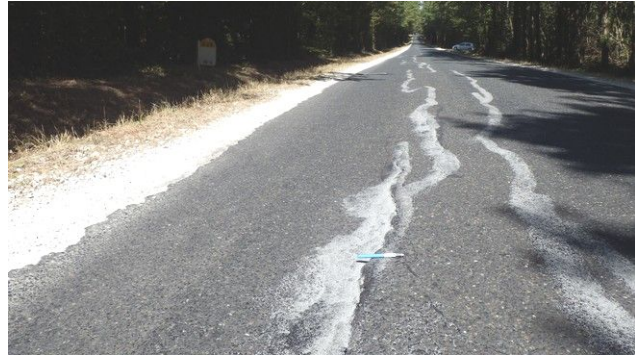
Illustration 41: PR 5 - September 2016

Unfortunately, summer and fall 2015 and 2016 were dryer and hotter and longitudinal cracking re-appeared (illustration 41). This crack will grow to become too large and the road manager was forced to repair it in May 2017.

The re-appearance of the longitudinal crack right to PR 5 indicates that the road confinement on -1.50 m seems insufficient in this context. Suction measurements recorded by the S2 probe at -2 meters depth corroborates this observation. There is a drying at greater depths.

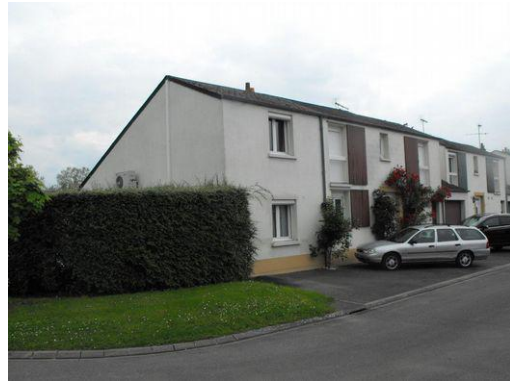
Illustration 43: View of the house

The MACH (illustration 42) is located in Mer (Loir-et-Cher, France). The house (illustration 43) was built in 1968. It is a one storey house with an extension which has been built in 1995 on the East side of the former house. The foundation system is a footing and the floor is a slab-on-ground one. The house is located in a residential area where vegetation is rather small and cared (owner’s gardens and some trees in the streets). The MACH is an inhabited house. It was excluded from the French compensating system for the drought of 2015. Thus, the owners are really involved in the experiment in order to repair their dwelling.

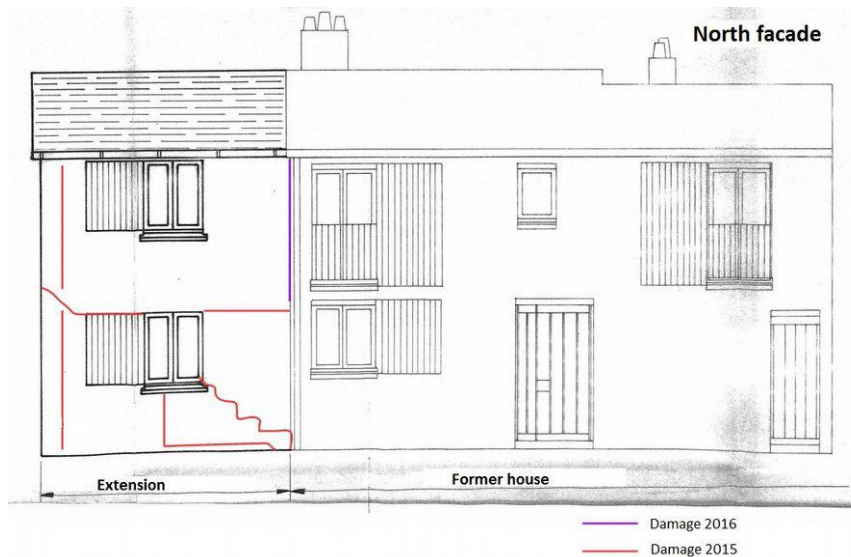
Illustration 44: Noticed damage survey in 2015 and 2016

After Summer 2015, the damages were noted only on the extension part of the house. Major cracks were drawn on illustration 44. It was found out that the extension is tilting to the East.

Inside the house, the floor did not settle at all. However, the tiled floor is broken at the junction of the former construction and the extension. The tilting phenomenon induced damages on the interior finishing (cracks on partition and doubling walls, offset of windows panels, doors which doesn't close or open...). These damages reduced during Winter 2015/2016 and increased during Summer and Fall 2016.

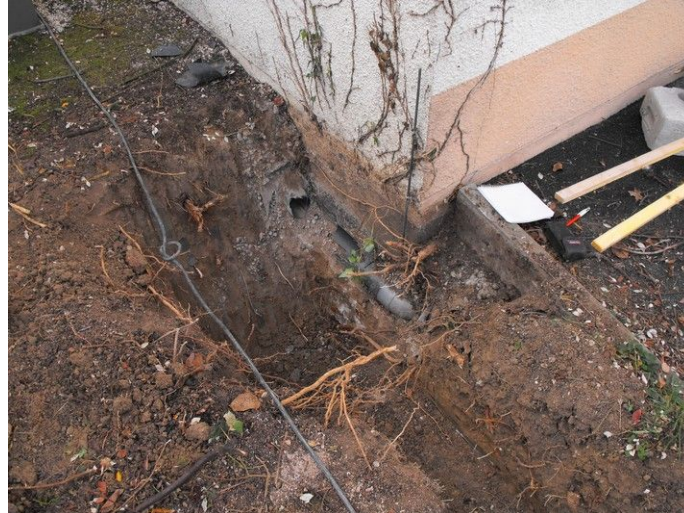
Illustration 47: excavator drilling (with numerous roots)

An excavator drilling was realized in front of the most damaged edge of the house. It shows that the foundation system, which is an 85 cm deep footing, is set on the soft and plastic clay. The footing is 35 cm thick. Numerous roots are observed in the excavation (see illustration 47).

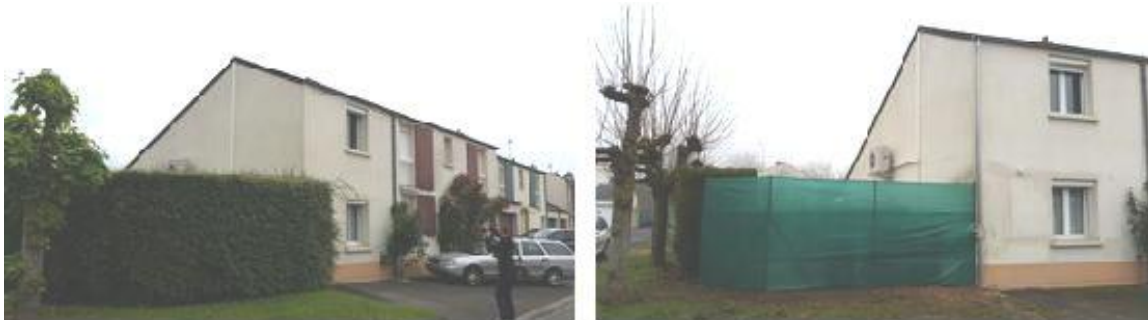
Illustration 48: MACH's views before removing the hedge and after

Early November 2016, the cotoneaster hedge and the wisteria were removed (see illustration 48). The hedge was substituted by a metallic fence with a green screen.

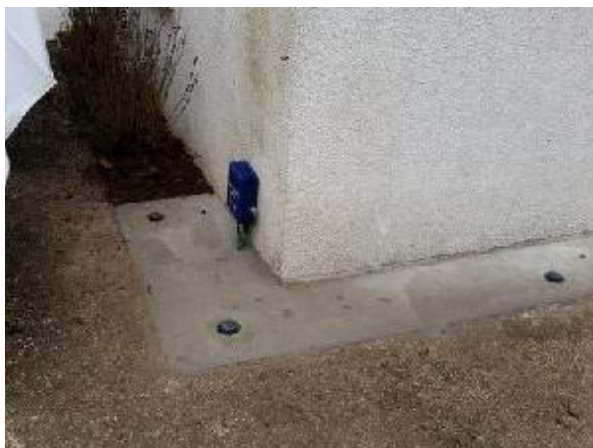
Illustration 51: Outside data-logger

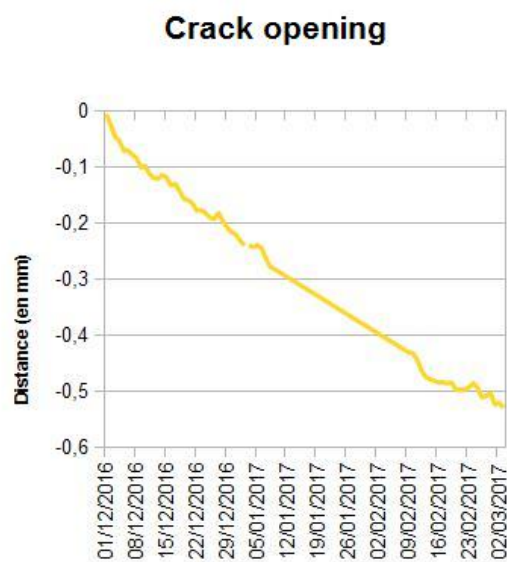
Illustration 53: Crack monitoring
