Ancient earthquake: Patara aqueduct, Turkey

Divona aqueduct:

Cahors (Divona Cadurcorum) $15 BC - AD 12 to \pm 4th century$

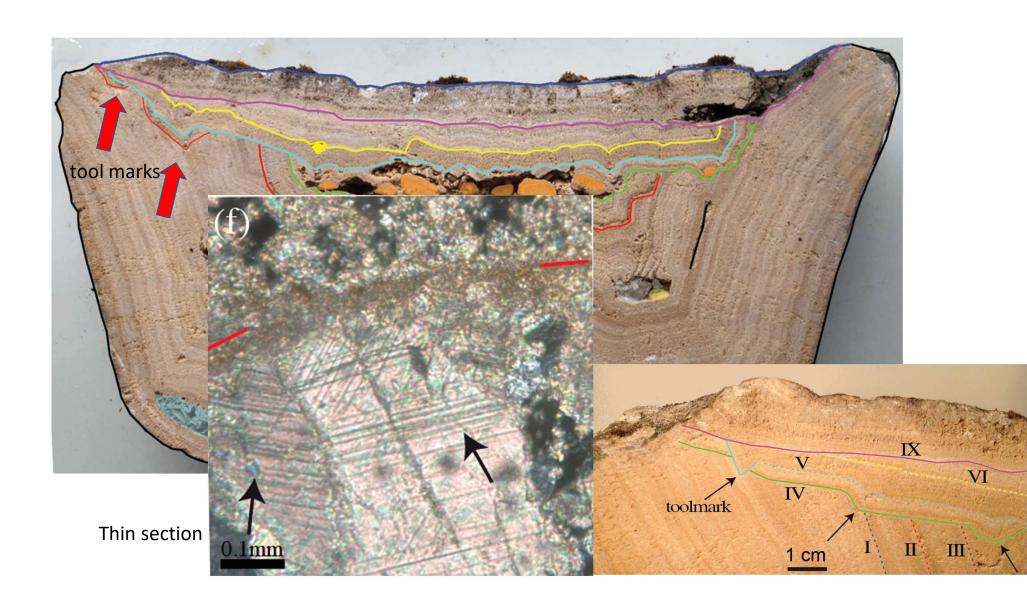
Deformation twins in calcite crystals and tool marks

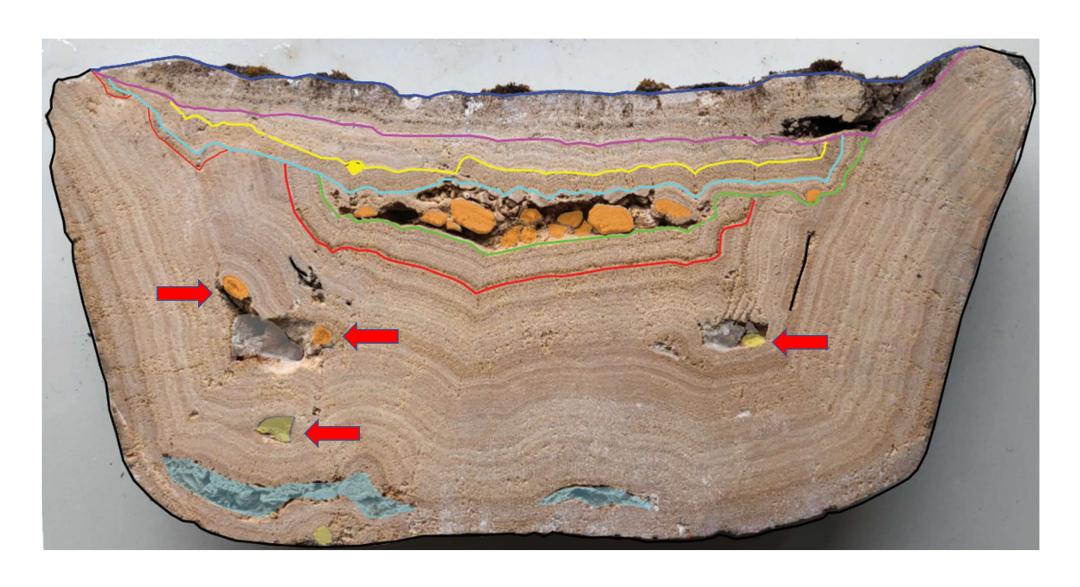
Mortar, limestone, spherulite, tile fragments...upstream maintenance traces

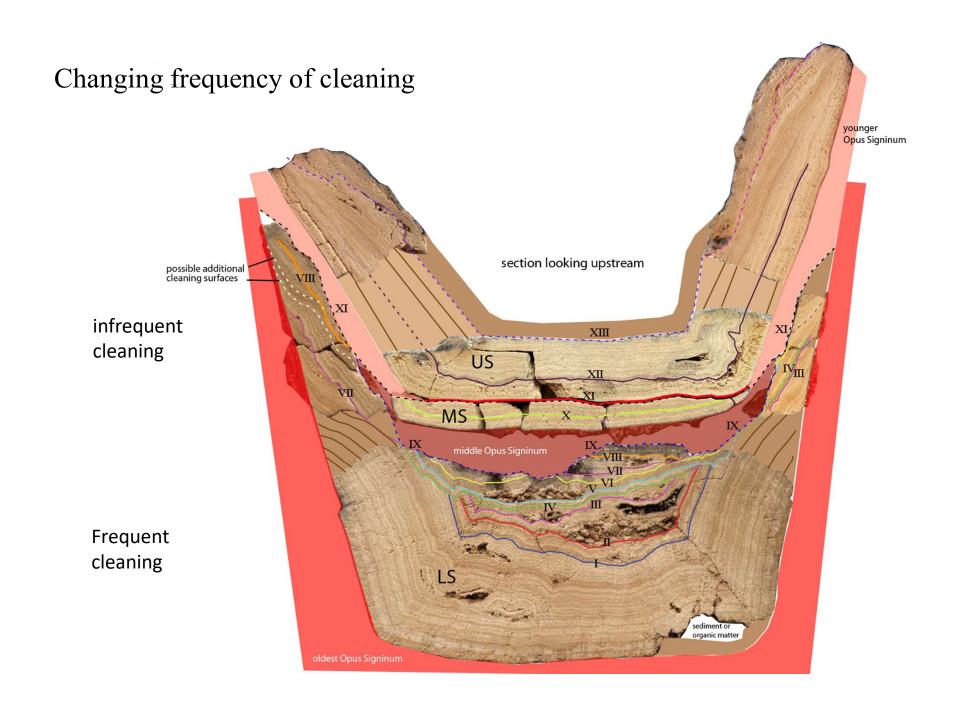
Life story of 88 years

Changing frequency of maintenance: changing socio-economy, maintenance strategy, population...

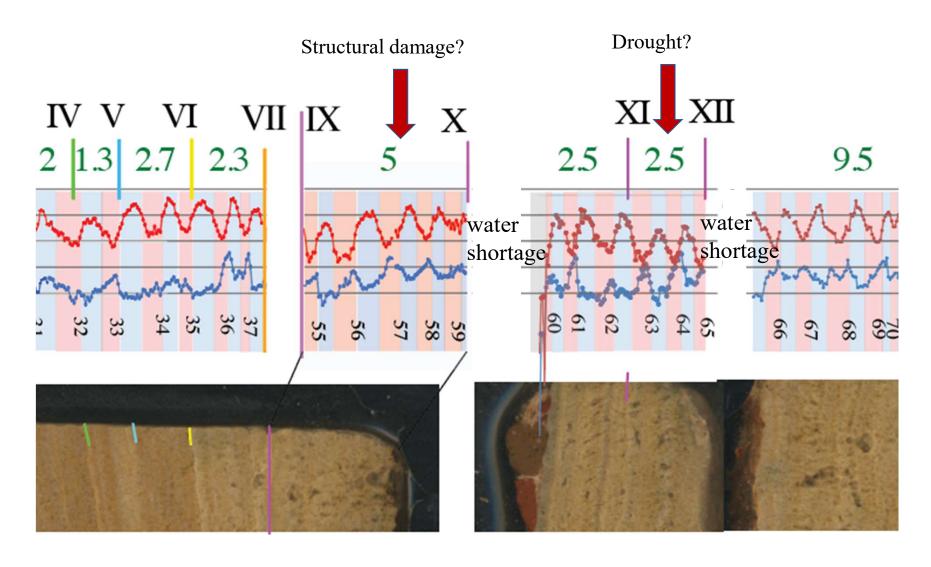
Truncations: evidences of times of water interruptions
