Repairing a damaged house by watering foundations: the MACH project

ABSTRACT

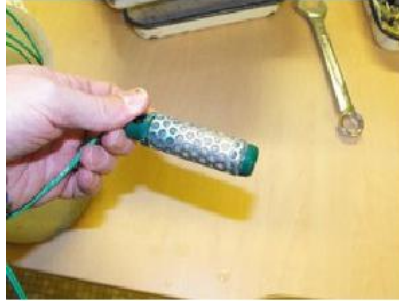
Figure 11: Tensiometric probe

Tension is a concept used in the agronomy field. It gives information about direction of hydraulic flows in the soil and on the available water for cultivating. Tension measurement allows to quantify, on a given point, the attraction force applied by solid particles on water. It is given in kilo Pascal (kPa) and is called, in the soil mechanics field, “soil suction”. Suction and moisture content are linked. Previous research works (Mathon and al. 2015) aimed to correlate them based on an experimental approach of drying. Under a given moisture content (which corresponds to the air inlet), the more tension is increasing, the more moisture content is decreasing. The tensiometric probes (see figure 11) are recording an electric resistivity of a gypsum piece, which is water balanced with natural soil. In the MACH project, 20 probes were driven into the soil at the same depth than the water injection points (about 1 meter depth).

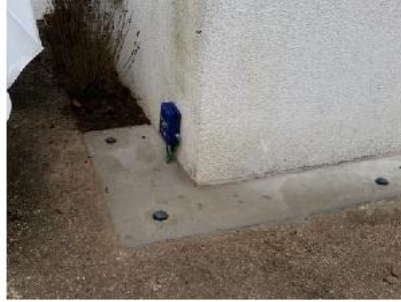
Figure 12: Outside data-logger

Each probe is linked to a data-logger unit which is located on the south facade of the house (see figure 12). This data-logger send 4 times a day tensiometric information to the Cerema. Thus, soil drying is monitored and water injection can be decided as soon as the engineer analyzes the tensiometric graphs.
