Croydon Tram Accident 9 November 2016

The Accident

Main findings of the RAIB investigation

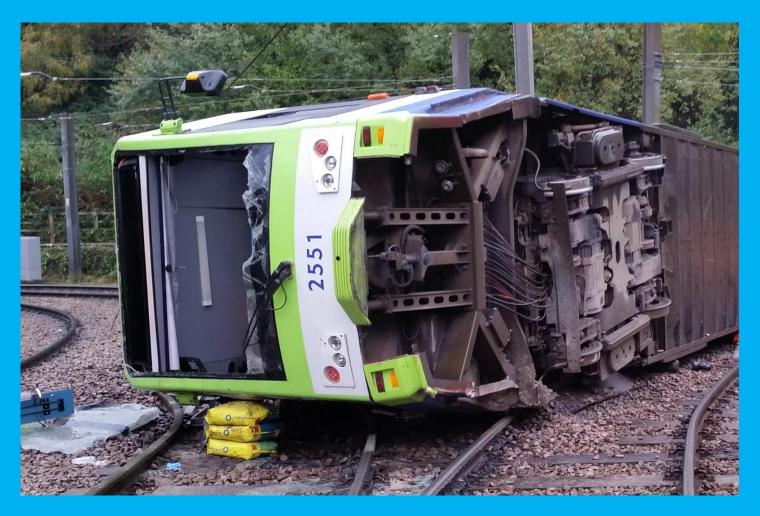
- 9 November 2016 at 06:07
- Dark, raining
- Sandilands Curve, 30m radius, limit 20 km/h
- Tram entered curve at 73 km/h
- Tram overturned and slid 20 metres
- 7 passengers killed, 62 injured (19 seriously)
 - Only 1 passenger escaped injury
- Passengers killed by being ejected through broken windows and doors
