**« Collision of two tramways in Paris »  
11<sup>th</sup> February 2019  
On-going investigation**

**Laetitia FONTAINE**

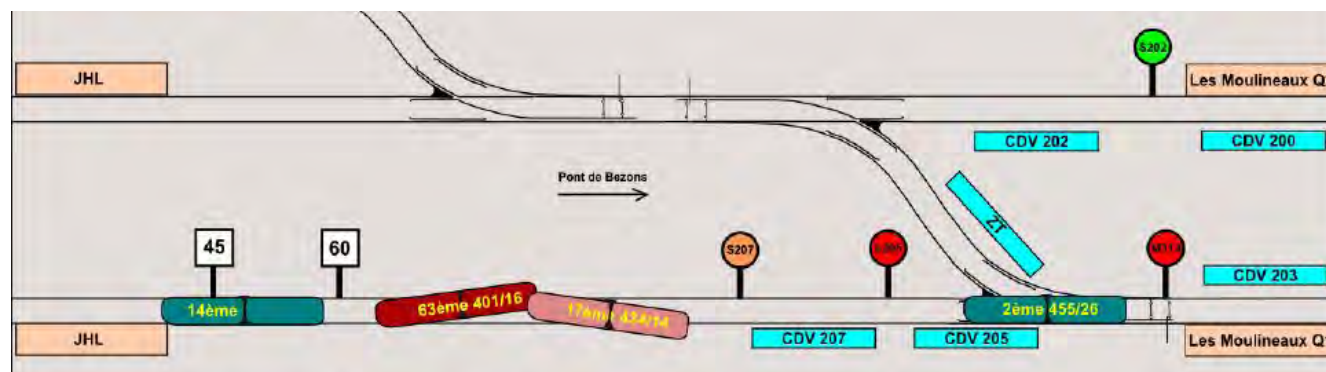
- On Monday the 11th of February 2019 around 21:00
- On line T2 at Issy-les-Moulineaux, next to Paris
- Between stations Jacques-Henri Lartigue and Les-Moulineaux, in direction of Pont de Bezons
- Collision between two double-rolling stocks, one stopped in front of a signal, waited there and the other (401/16) hit it to the rear

- Consequence = derailment of both involved tramways
- Maintenance worker alerts the PCL
- Operation and energy are stopped

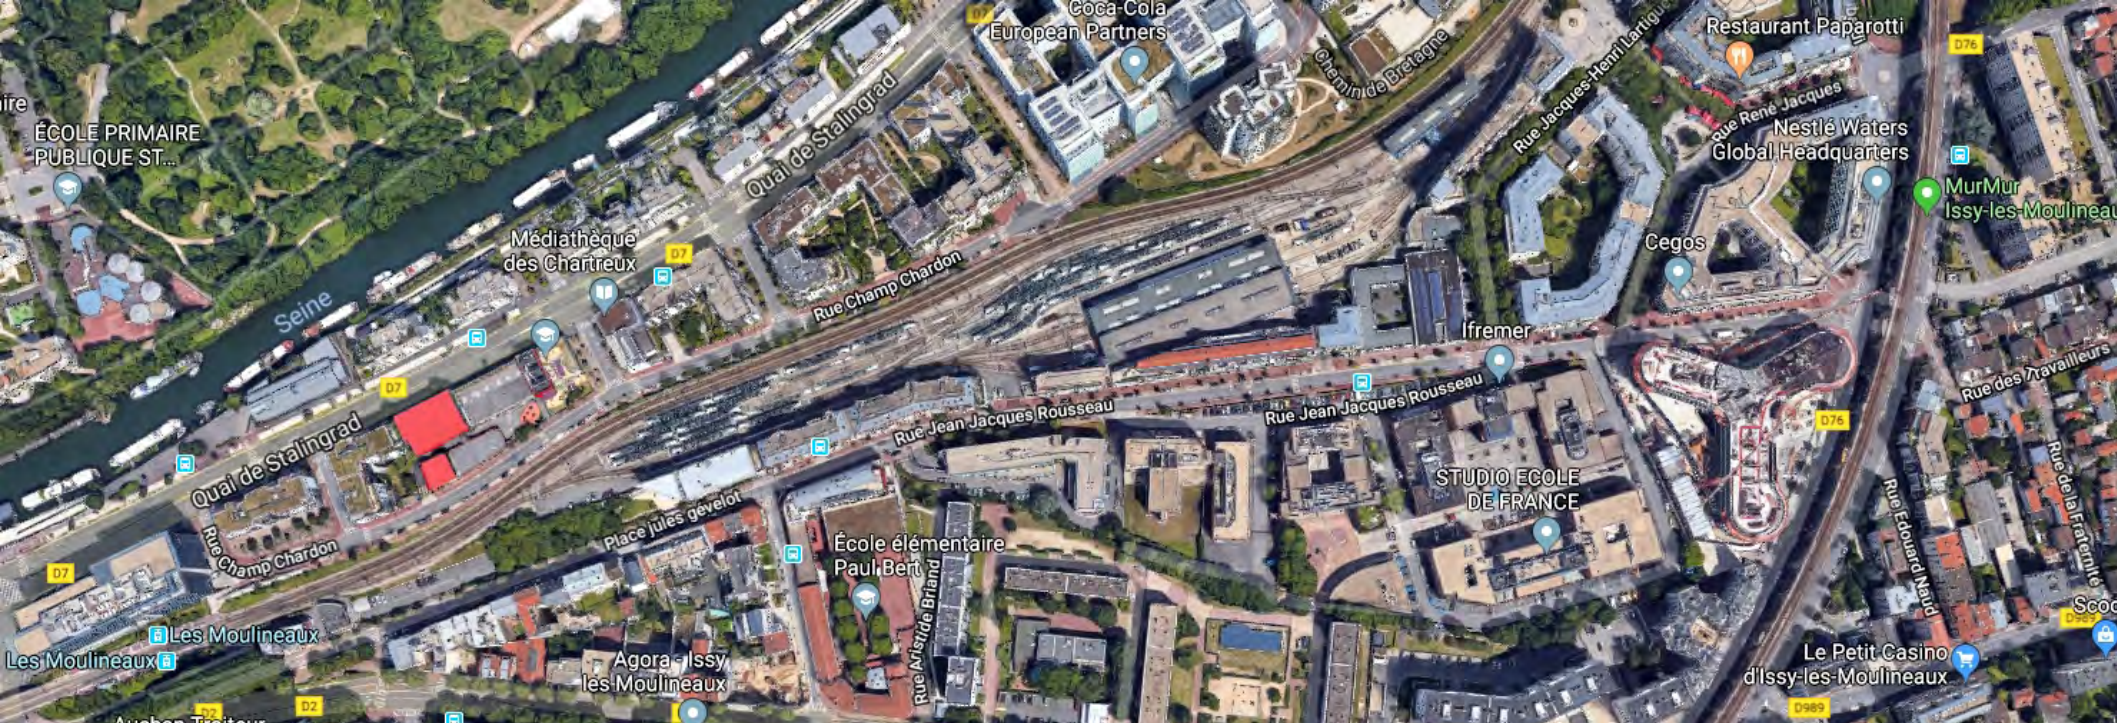
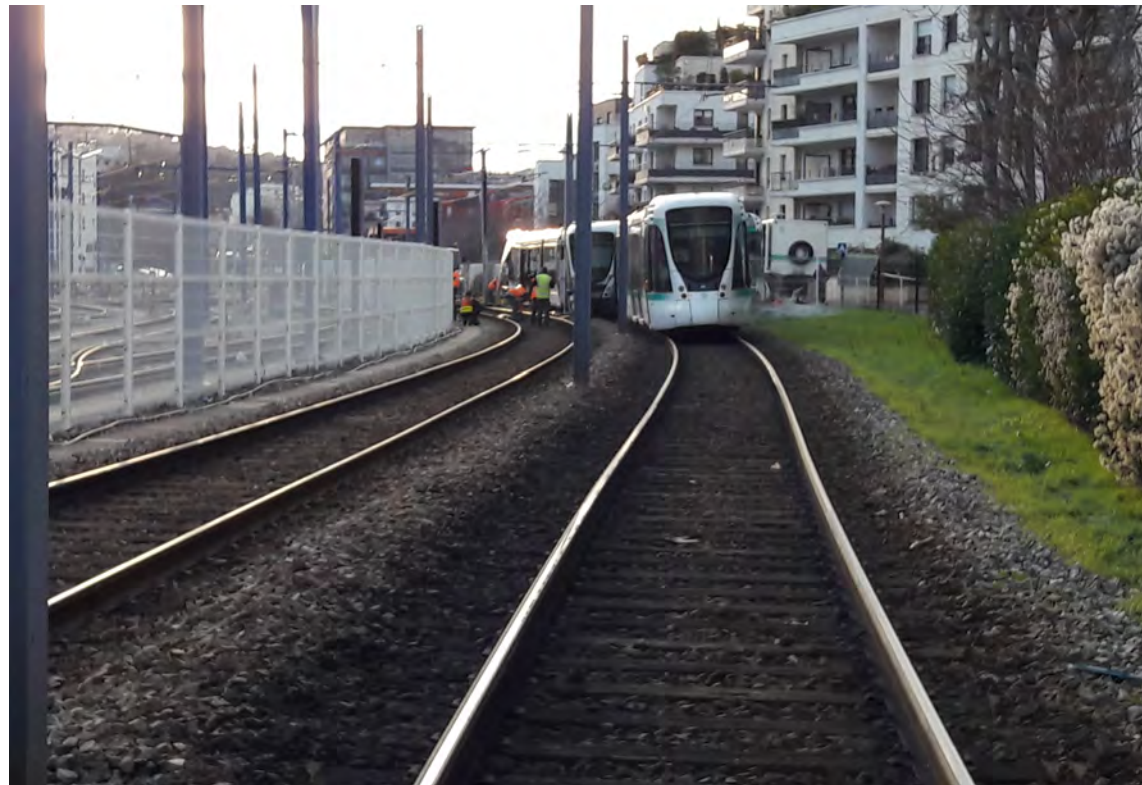
- No road or pedestrian intersection
- Slight curve
- Speed limit is 60 km/h (max of the T2 line is 70)
- Ballast + protected by fences and bushes

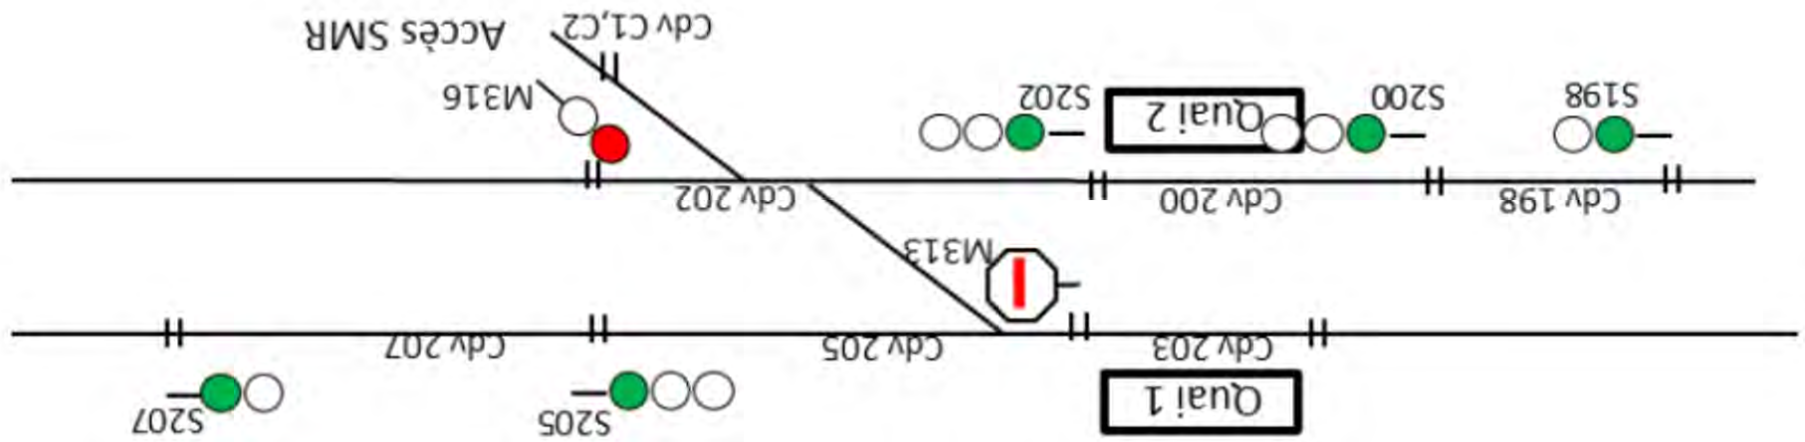
Les Moulineaux station

## The zone and lights when there is no tram

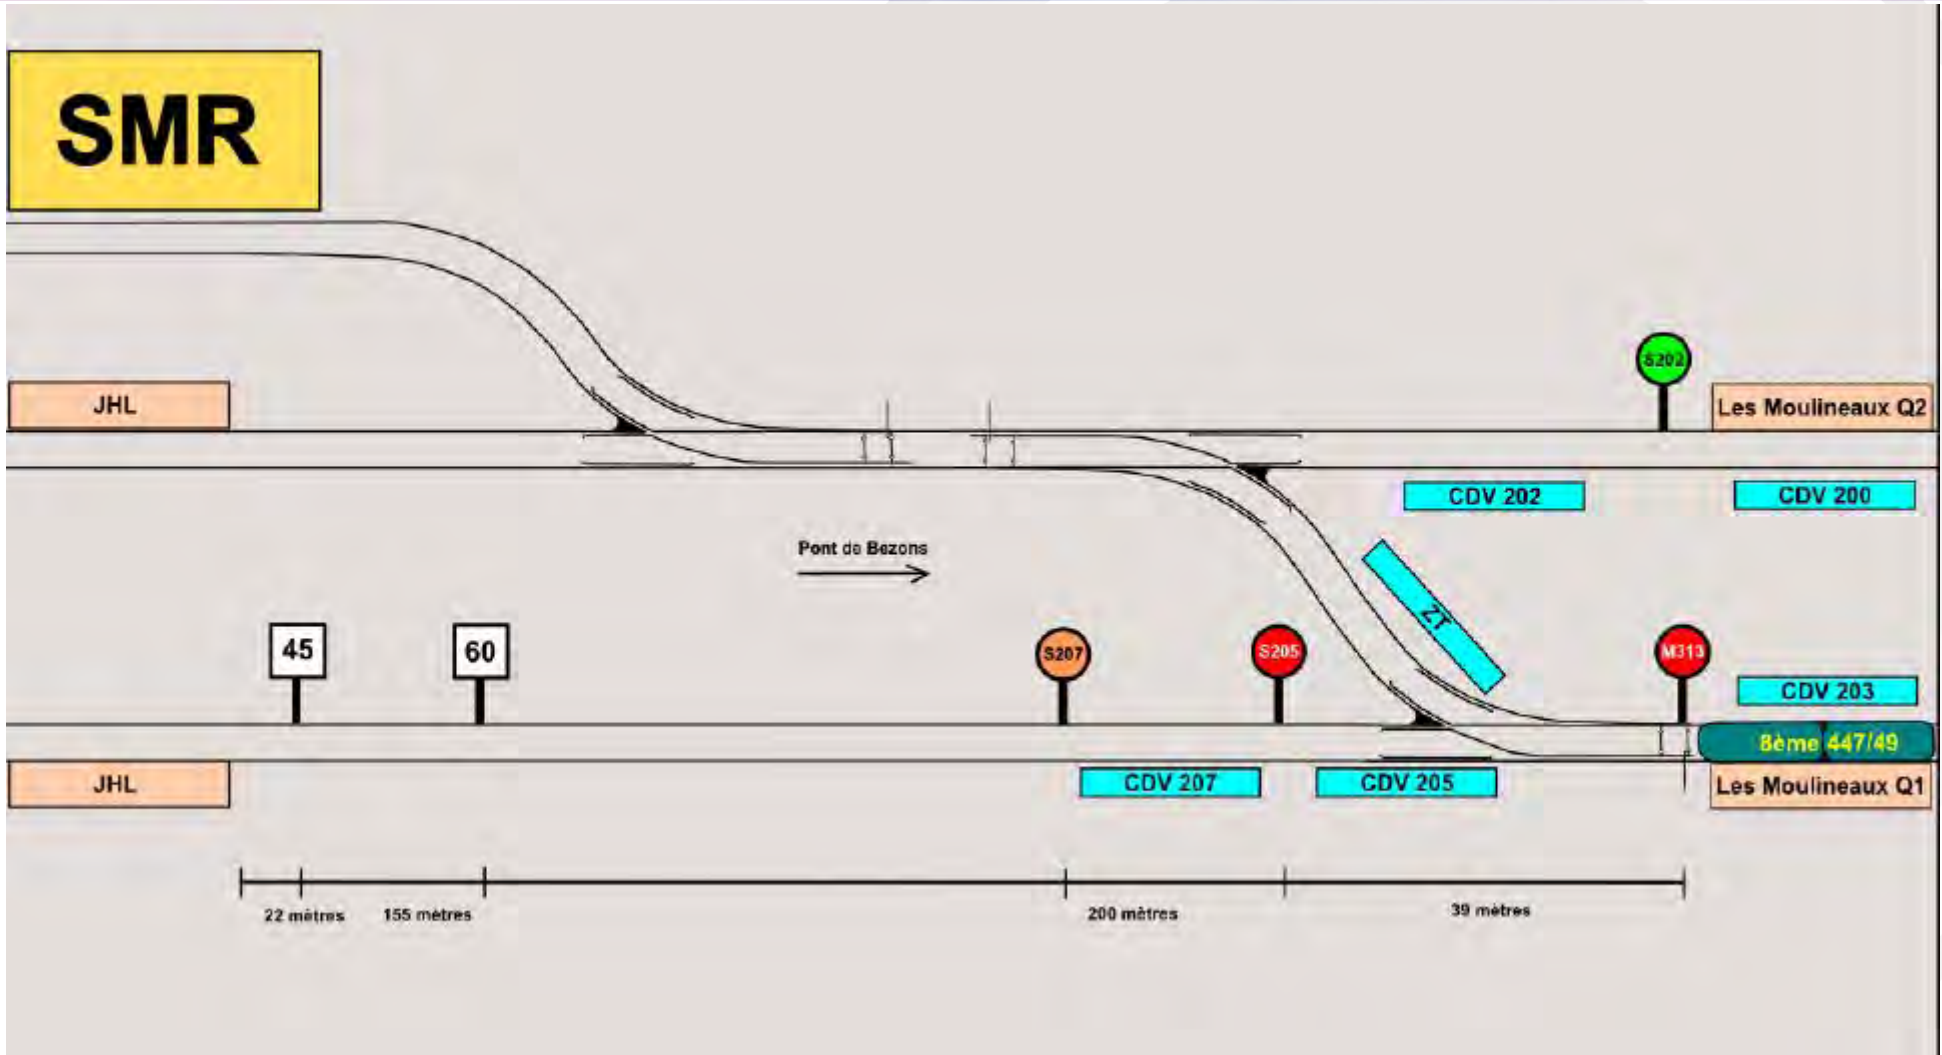
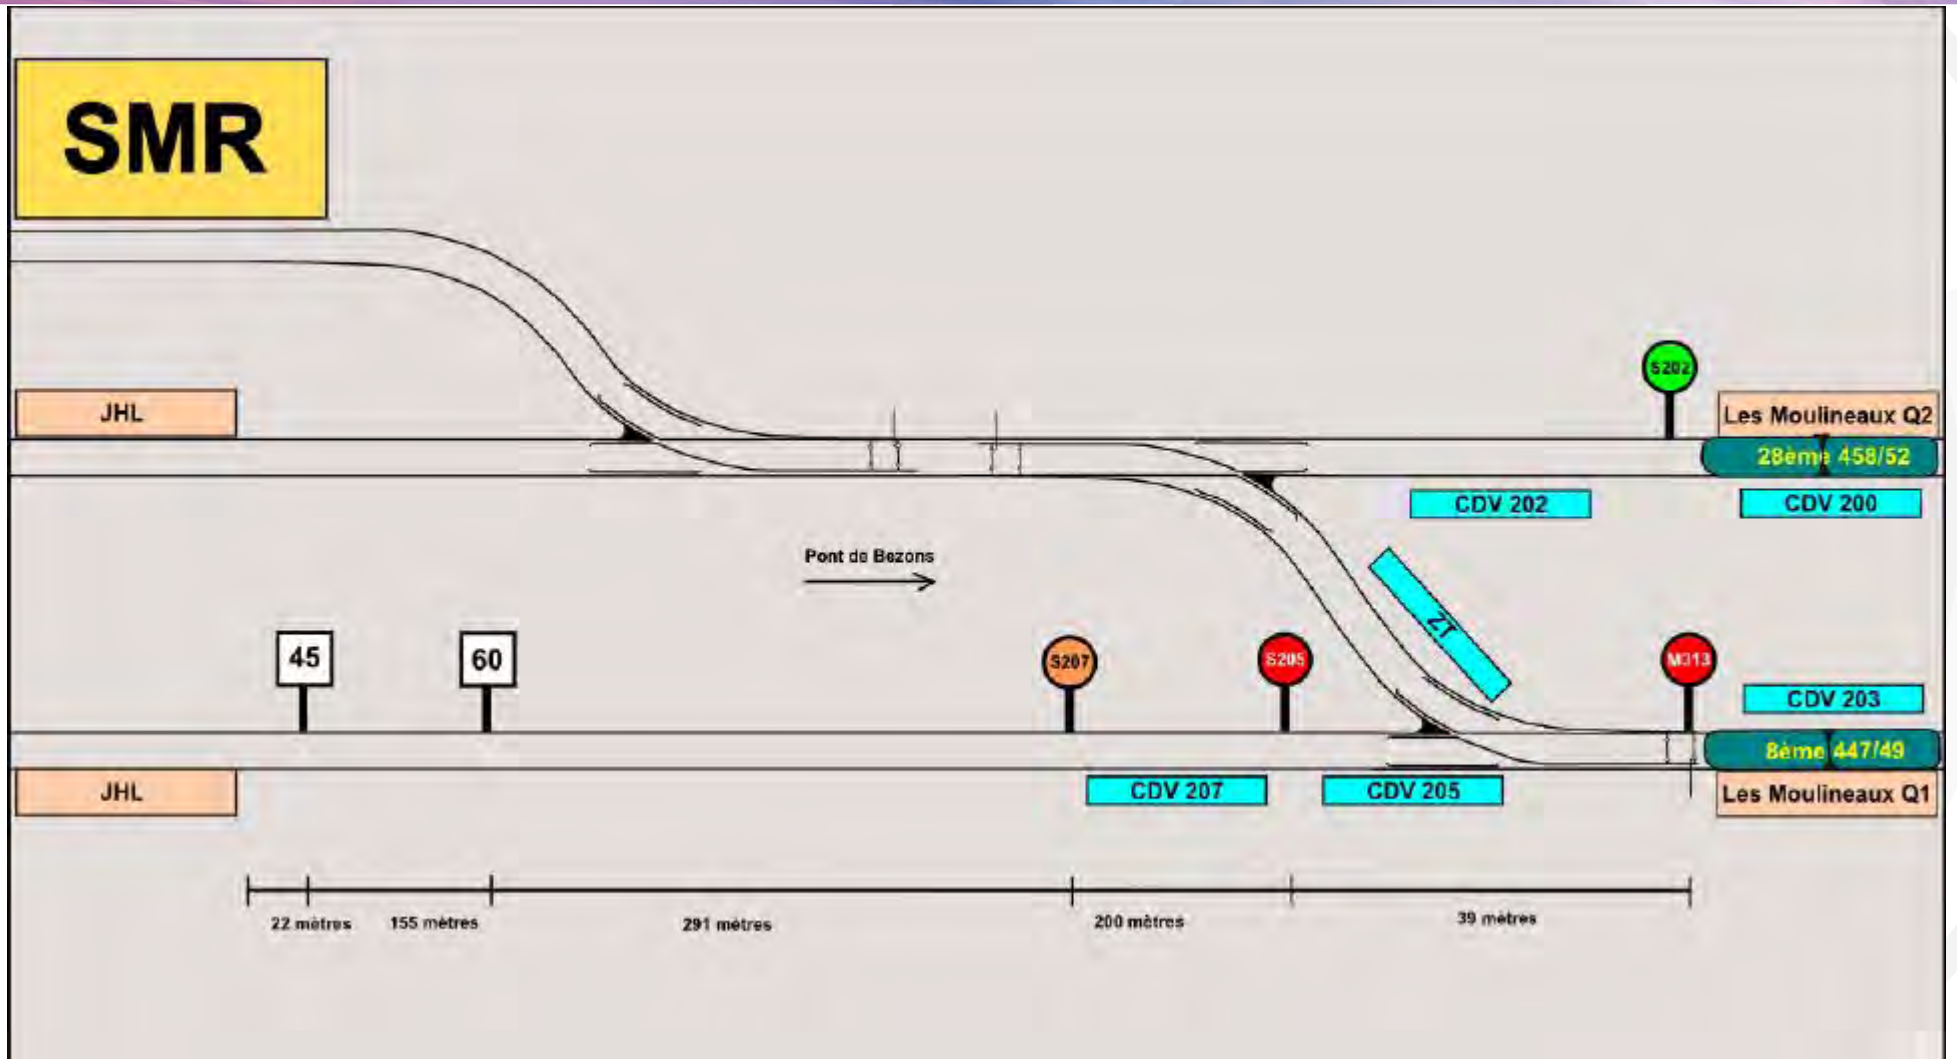
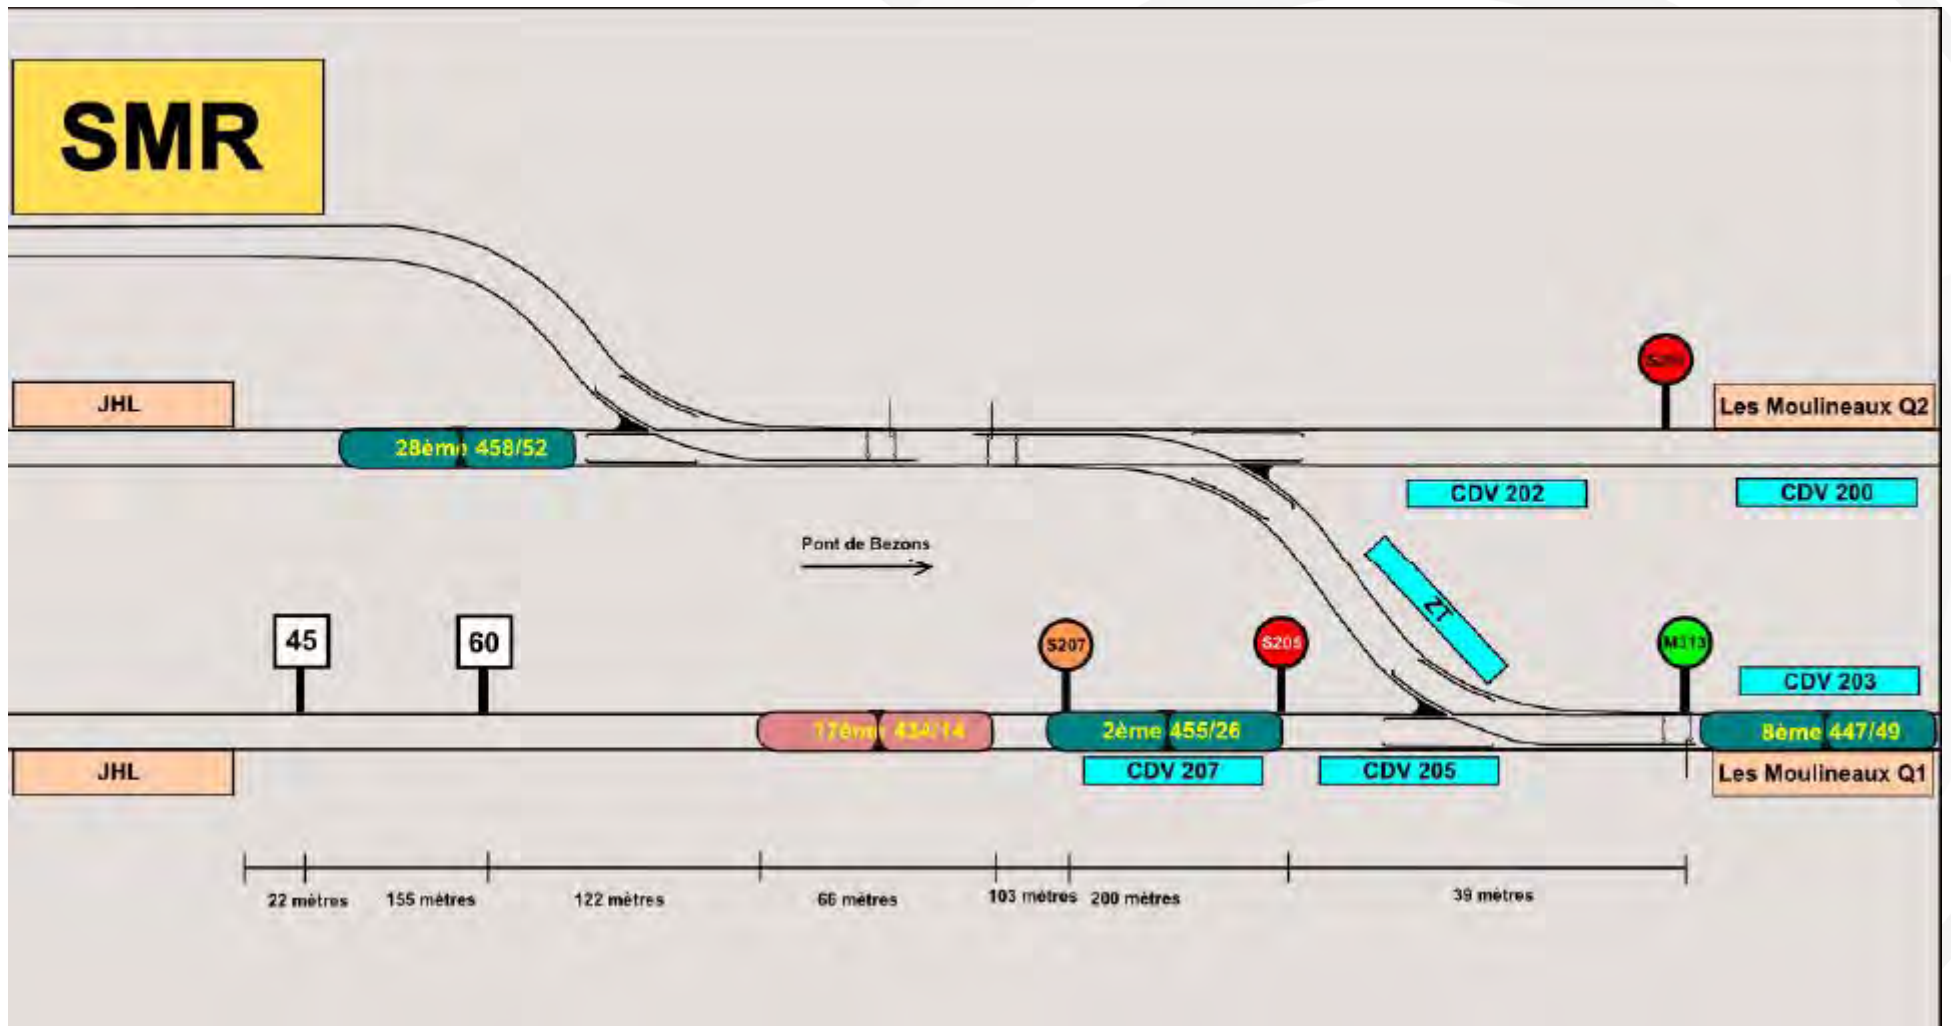
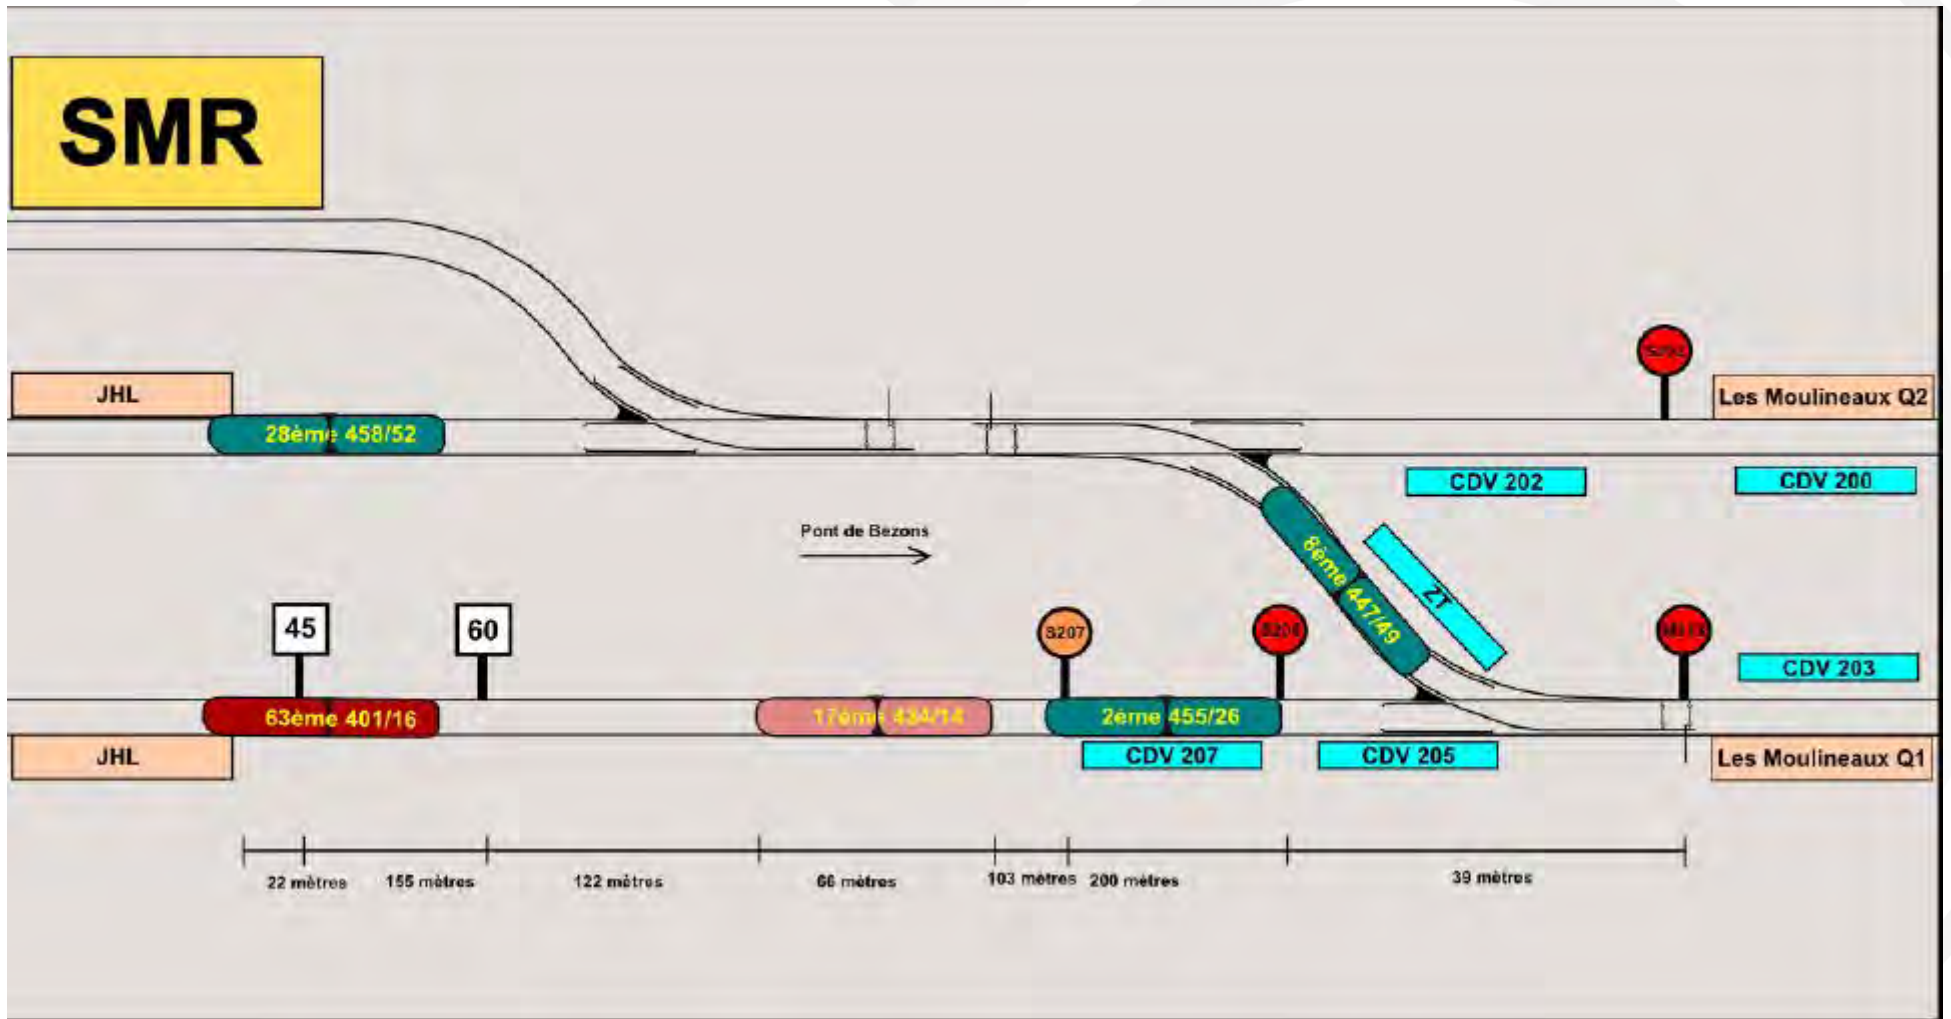
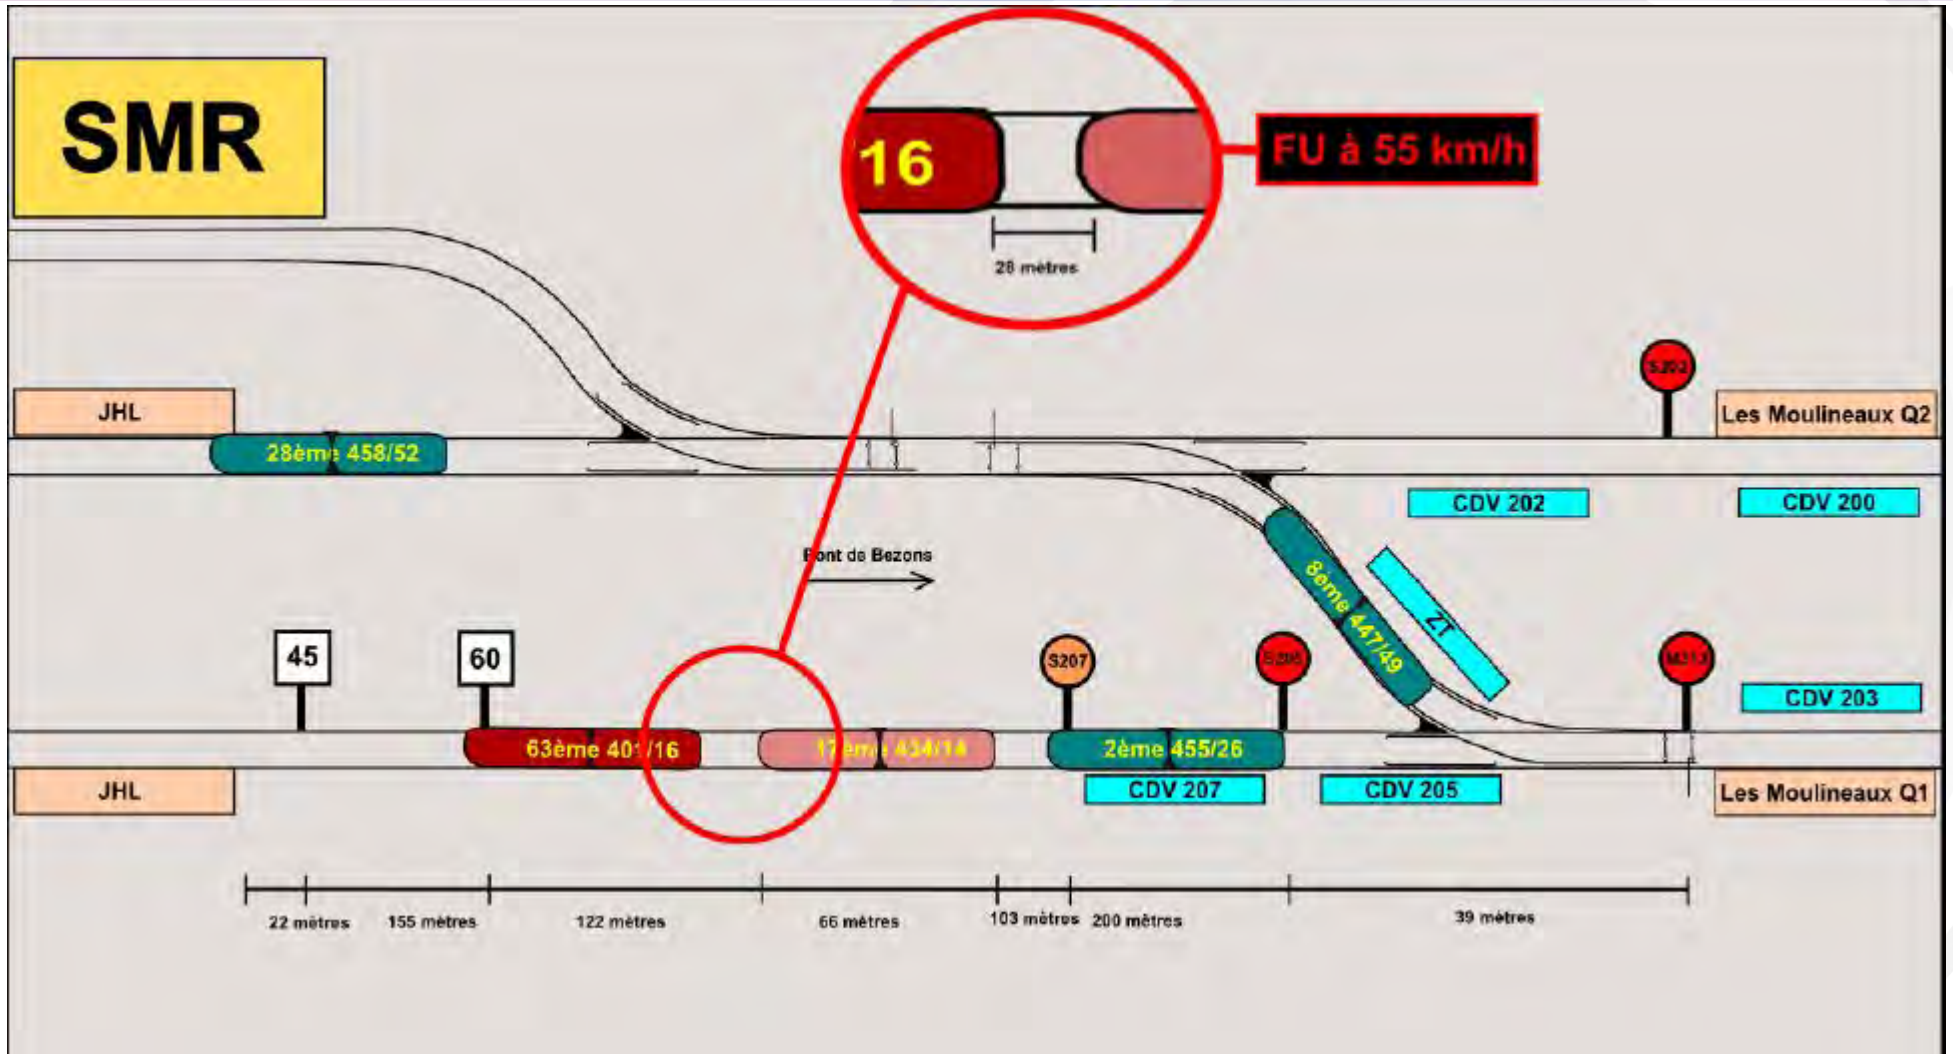
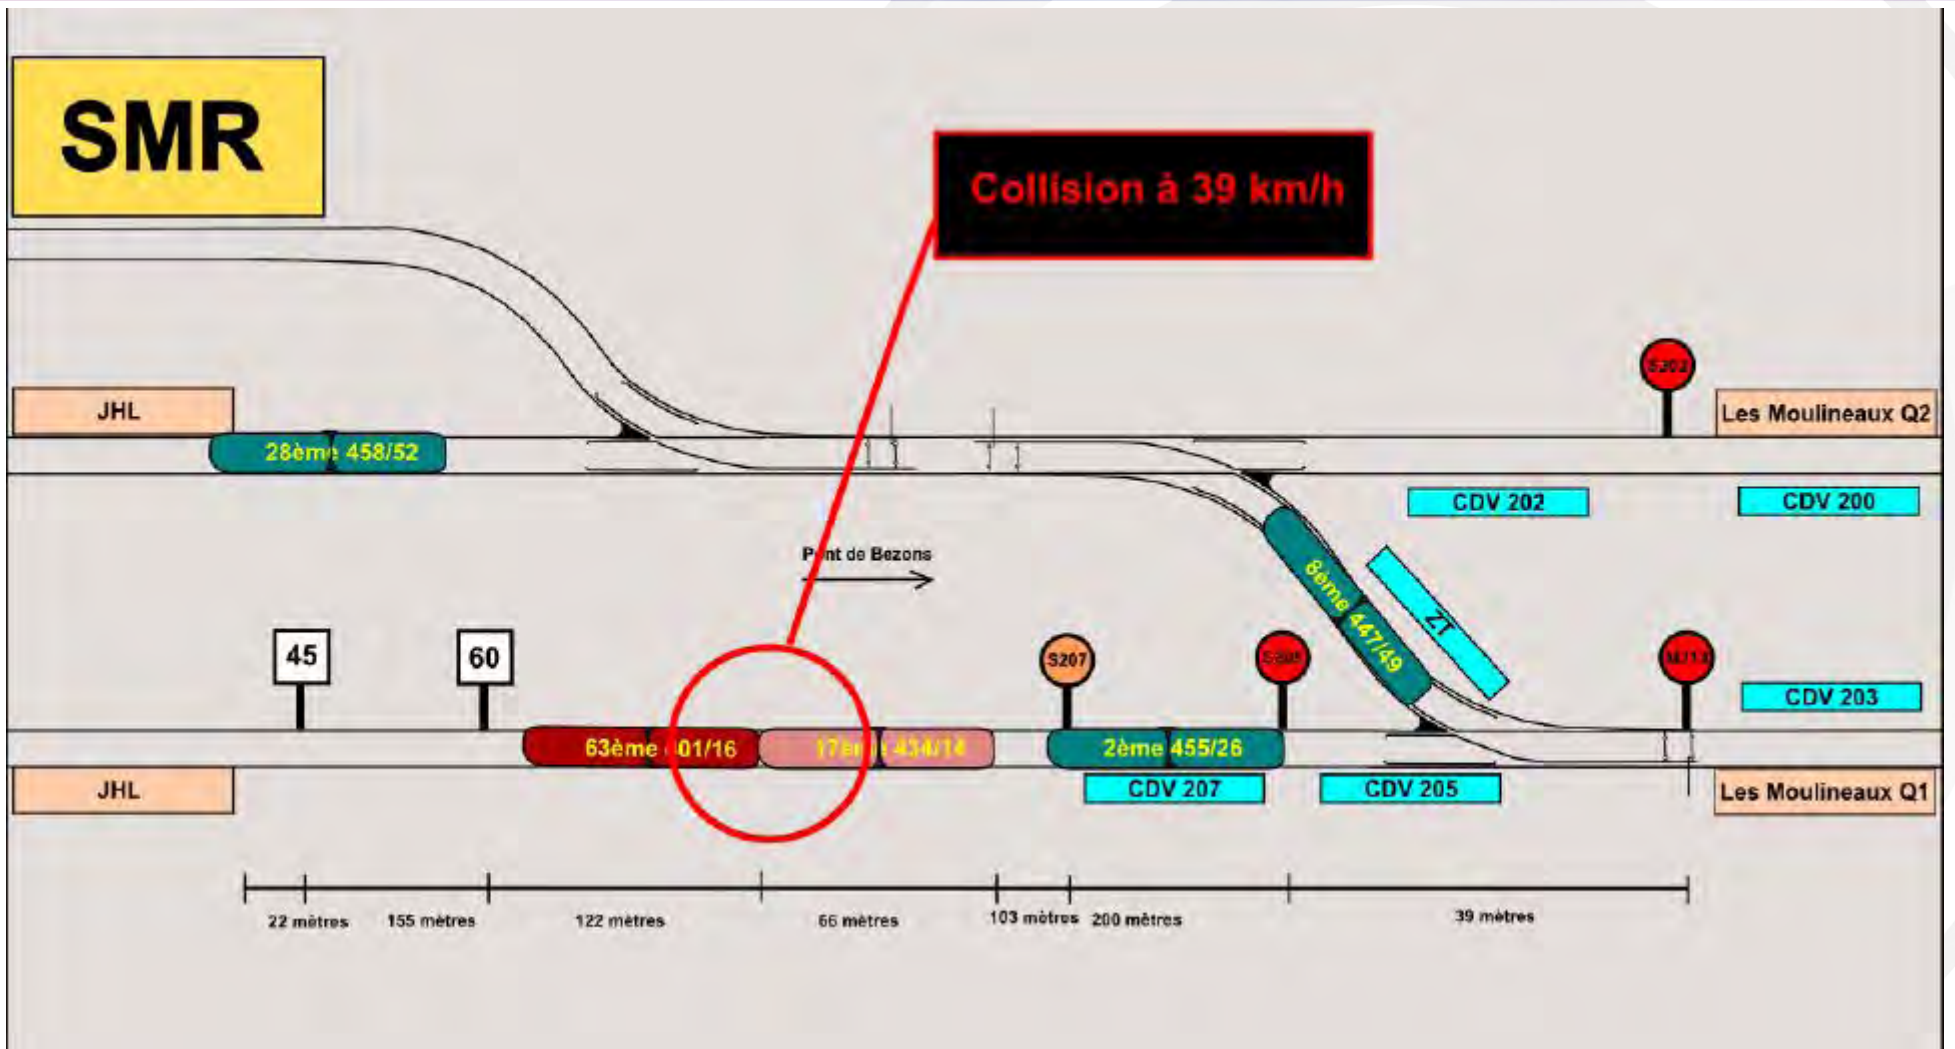
The collision step by step
